FROM: Iowa FACE Case No. 2004IA051 Report Date: 26 August 2008

SUBJECT: Driver pinned under haul truck that went off quarry road and tipped over

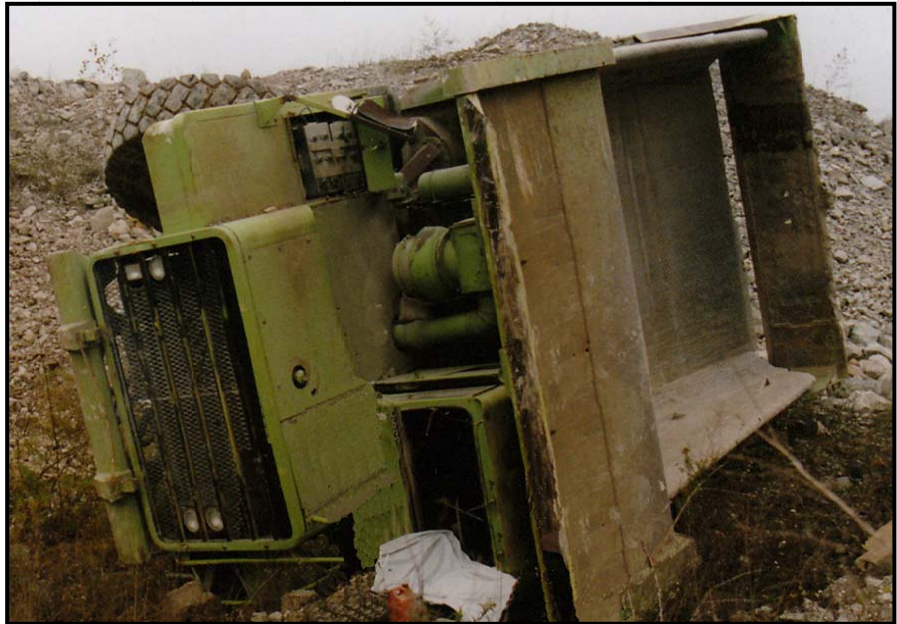
A 58-year-old man died mid autumn 2004 at a surface limestone quarry in southeast Iowa. The loaded haul truck he was driving down the pit road went off the pit side of the roadway. It continued down slope across the rock-covered bank. The driver jumped or was ejected and was pinned under the left front corner of the cab as the truck came to rest on its left side near the base of the slope (Photo 1).

Photo 1 – Haul truck came to rest on its unbelted operator who was ejected or jumped.
