**Case No. 3IA54**

**Report Date: March 17, 2004**

**SUBJECT: Farmer Crushed Under Bucket of a Skid-Steer Loader**

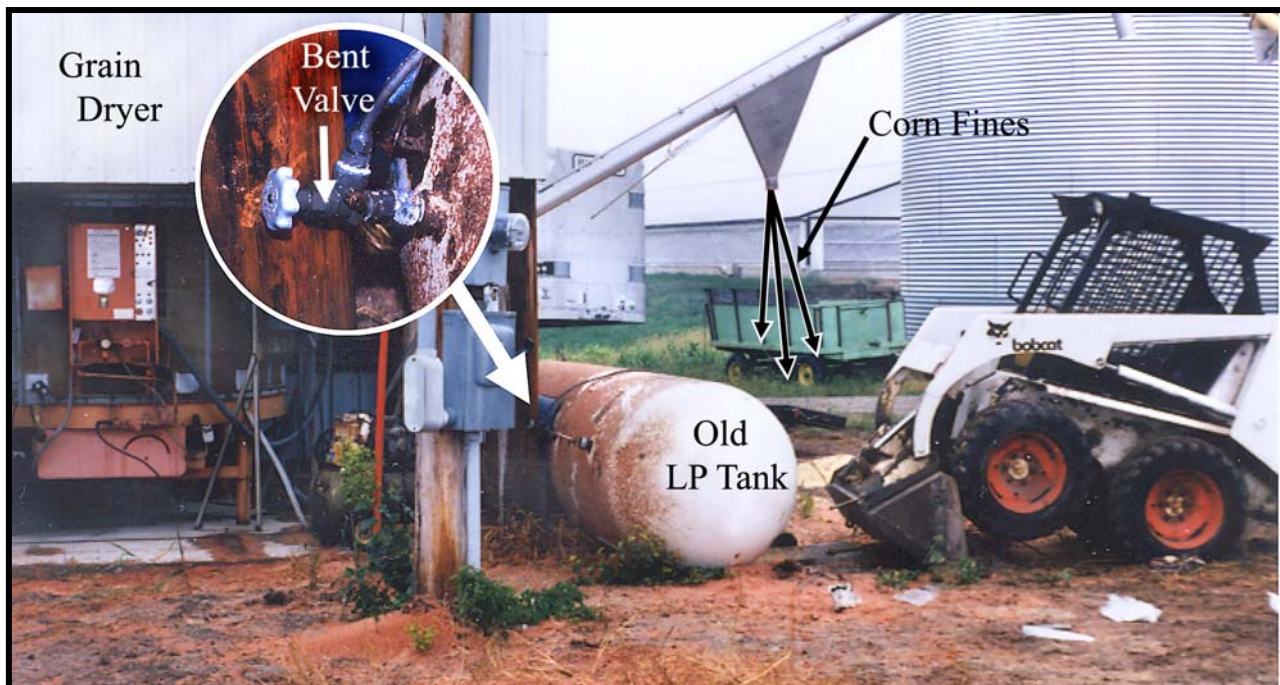
Photo 1 – Side view of area showing skid-steer loader in the position it was found, overhead grain auger, propane tank (liquid petroleum, LP) overturned against a pole for the dryer, and a close-up of the bent propane valve.

The fatality occurred during harvest at a farm grain handling site in Iowa. The farmer was moving corn from the grain dryer to a bin with an overhead auger, as seen in Photo 1. A pile of corn fines accumulated on the ground beneath the auger, and the farmer was using the skid-steer loader to move the fines out of the way to a location in an adjacent field. The grain dryer was in operation, receiving propane from the adjacent tank. The farmer was working alone, operating an older skid-steer loader, which he had recently purchased. The loader was a 1980 Bobcat, model 631. It had a seatbelt but no electrical or mechanical safety interlocks that would control the hydraulics if the operator was not sitting in the seat. The seatbelt was not used at the time of the incident.

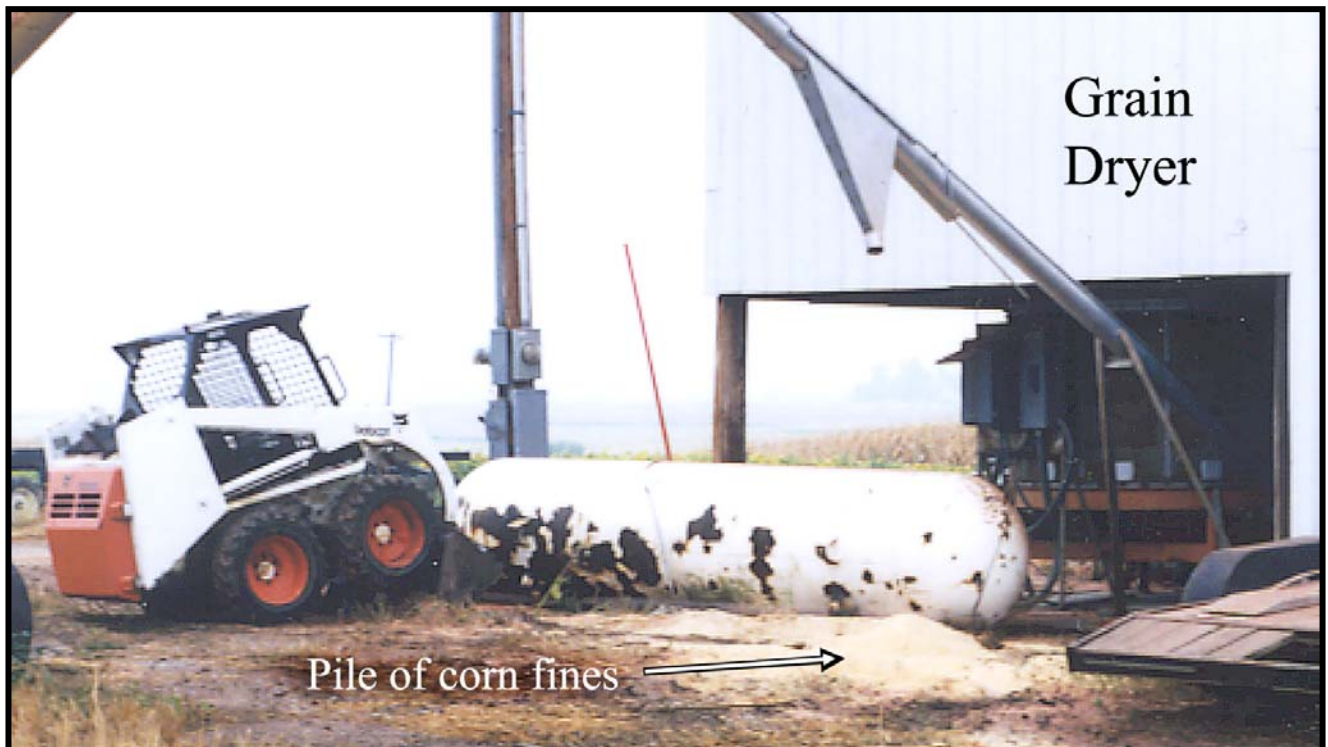
Photo 2 – Back view of the area showing skid-steer loader, overturned tank, the grain dryer, and the pile of corn fines.

It had rained the night before, so it was possible for Sheriff's investigators to determine where the loader had been operating that morning by observing fresh tracks in the dirt. It appeared that while loading up fines with the bucket, the farmer accidentally backed into one end of the propane tank, knocking it off its concrete foundation. Fresh marks in the paint on the tank and tracks in the dirt suggest the farmer was trying to re-position the tank after it had tipped over on its side, toward the grain dryer. The top-mounted valve (see Photo 1) had struck a dryer pole and was venting propane. The farmer moved the loader to the opposite end of the tank and raised the bucket, possibly preparing to reposition the tank with a chain. Considering the noise level from the dryer and the skid-steer loader, it's not clear whether he heard the sound of the leaking propane. However, it is likely he noticed the odor of the leaking gas, and knew it was an explosion hazard. Either the grain dryer, which was running, or the skid-steer loader itself could ignite the propane, and the farmer was likely aware of this and had great urgency to correct the situation.

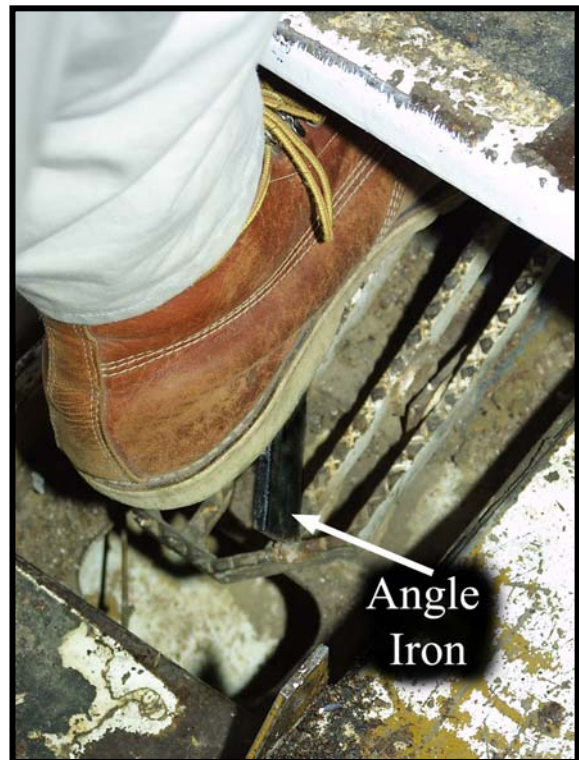
This 1980 model skid-steer loader showed wear from previous use. The foot pedal linkages were worn and metal risers had been added to the heel portions of the pedals (see Photo 3). The riser on the left pedal was welded, and the raiser on the right pedal was fitted to slots in the pedal. These risers allowed a more normal heel position when raising the lift arms and tilting the bucket up, but they restricted the already tight space in the foot wells, and added points where the operator's feet could get caught. However, it is unknown whether these risers contributed to this fatality.

Photo 3 –View of left foot pedal, showing angle iron welded to the heel portion of the pedal.

**Discussion:** A previous owner of this machine had added risers to the heel portion of the foot pedals. The pedal linkages were worn, and needed adjustment or repair. It appears the heel position for raising the lift arms and tilting the bucket up had become awkward, and to correct this, the quickest solution for the previous owner was to add more height to the pedals with metal risers. One of them was welded, and the other was fitted between the slots of the pedal. These modifications reduced room in the already tight space in the foot wells, creating more clutter and points where the feet could get caught and accidentally activate the hydraulic controls. It's not clear whether these modifications were a factor in this incident, however, they could compromise safe operation of the machine.

**Recommendation #3 Owners of skid-steer loaders should not modify machine controls.**

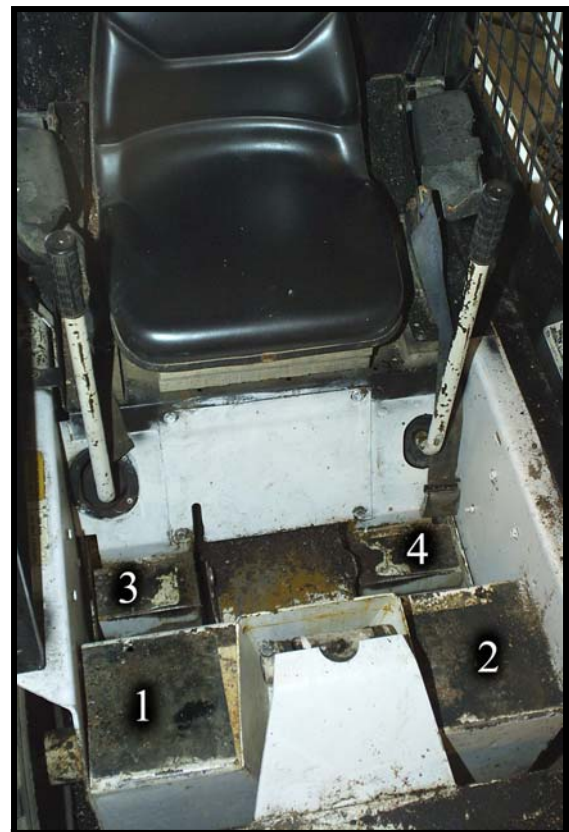
Photo 4 – Front view of operator compartment showing hand controls and four areas for the operator to step on.
