THE UNIVERSITY OF IOWA
Iowa City, Iowa 52242

FROM: Iowa FACE Program

SUBJECT: Construction worker crushed between falling dump box and truck frame.

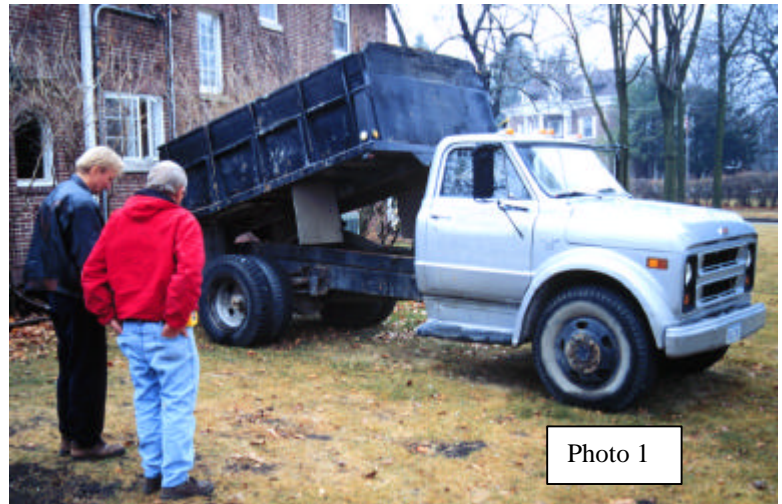
During the fall of 1999, a 53-year-old construction worker was killed after he unloaded sand from a dump truck. He partially raised the box of his truck to dump out a portion of wet sand at a work location, then leaned under the box to manually trip the hydraulic linkage to bring the box down. The hydraulic linkage was located at the hydraulic pump, behind the cab between the main frames of the truck. This action

was apparently a habit to save some time from walking around the truck to push the dump lever inside the truck cab. However, this time, because of the heavy load of sand, and because the box was only partially raised, the truck box came down immediately pinning the man between the box and the frame of the dump truck. The man suffered massive head injuries and was dead at the scene. The deceased truck driver had several years of experience with machinery and was the lead man for the small construction company.

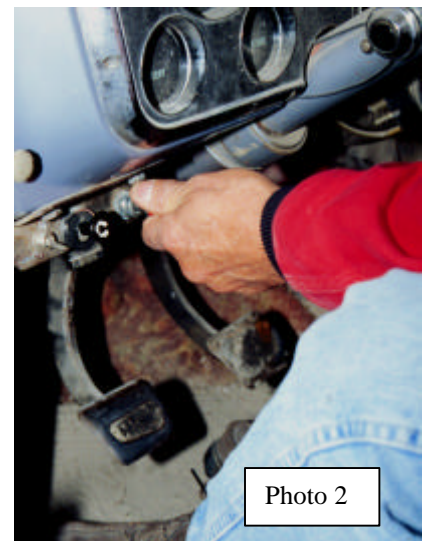
The dump truck was a 1968 model with a payload of seven tons. It was maintained by the victim and was in normal operating condition. The hydraulically-controlled dump box was actuated by a hand-operated knob inside the cab of the truck (see Photo 2), and controlled by the clutch pedal. A cable ran from the knob to a hydraulic valve located between the main frames of the truck (see Photo 3). When the box was raised, this cable end and actuator lever at the hydraulic pump housing were visible and within easy reach.

Recommendation #3 *Manufacturers of dump trucks should consider options to discourage unsafe use of dump box hydraulics, such as placement or shielding of controls.*

Discussion: The hydraulic linkage in this older dump truck was easily accessible from the sides of the truck when the box was raised. While this is an unexpected hazardous behavior, it might be possible to prevent such behaviors by placing the linkage where it cannot be easily reached or enclosing the linkage so that it could not be easily misused.

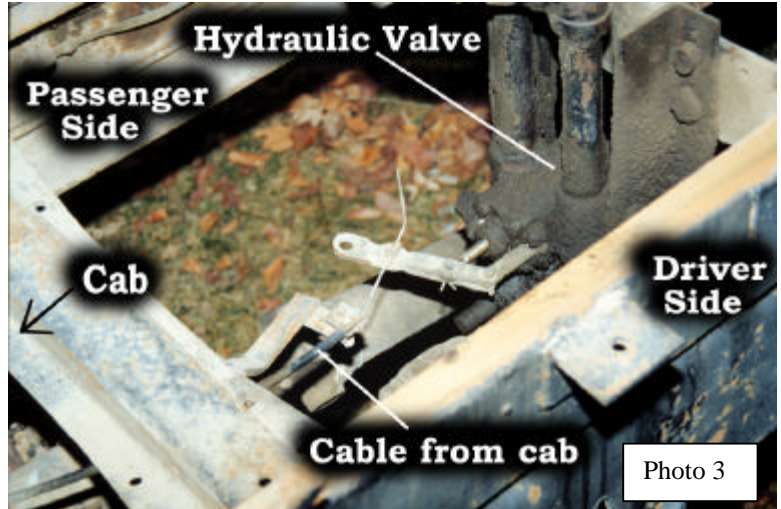
The victim partially raised the box of his dump truck and unloaded about 1/3 of the load of sand, which was wet and heavy. Then while standing and leaning in from the passenger side of the truck, he manually tripped the hydraulic control lever to bring the box down. However, due to the weight of the wet sand and the low height of the box, it slammed down immediately and pinned the man to the frame of the truck. He was killed instantly from severe head injuries.

Apparently the victim had lowered the truck box manually before instead of using the cable control inside the truck cab. Co-workers who witnessed him lowering the box in this manner at other job sites confirmed this. When the box was fully raised and the load was completely dumped, the box would descend slowly and he would have ample time to get out of the way. The victim had worked with this company for the last three years and probably had lowered a partially-raised truck box in this fashion many times. It is not clear whether he might have slipped, lost his balance, or got caught by his clothing, preventing him from escaping.

Recommendation #1 *Workers should use proper machine controls rather than actuating machine functions at hazardous locations.*

Discussion: The victim was in the process of dumping a partial load of wet sand. It appears he had developed a system of monitoring how much had been dumped by standing to the side of the dump truck, then at the proper time, manually releasing the dump box hydraulic lever to bring the box back down. This was probably a more accurate method of measuring how much had been dumped, rather than using the controls in the truck cab. In many cases the workers would be working alone, so it may not be possible to ask other workers to monitor and signal when the box should be lowered. This method had reportedly been used before, but on this day, perhaps because of the wet sand and the lower position of the box; the box may have fallen much faster. It is not known whether he slipped or got caught while trying to move out of the way of the falling truck box. However, during demonstrations, the box descended very fast giving little time to escape in a similar situation. Since the event was unwitnessed, the details of this accident will never be fully known. However, it is clear that actuating the hydraulics under the raised box is hazardous and should not be done in any circumstances.
