FROM: Iowa FACE Program Case No. 1IA021 Report Date: 7/24/03

SUBJECT: Two Railroad Repair Workers Asphyxiated in Damaged Tank Car.

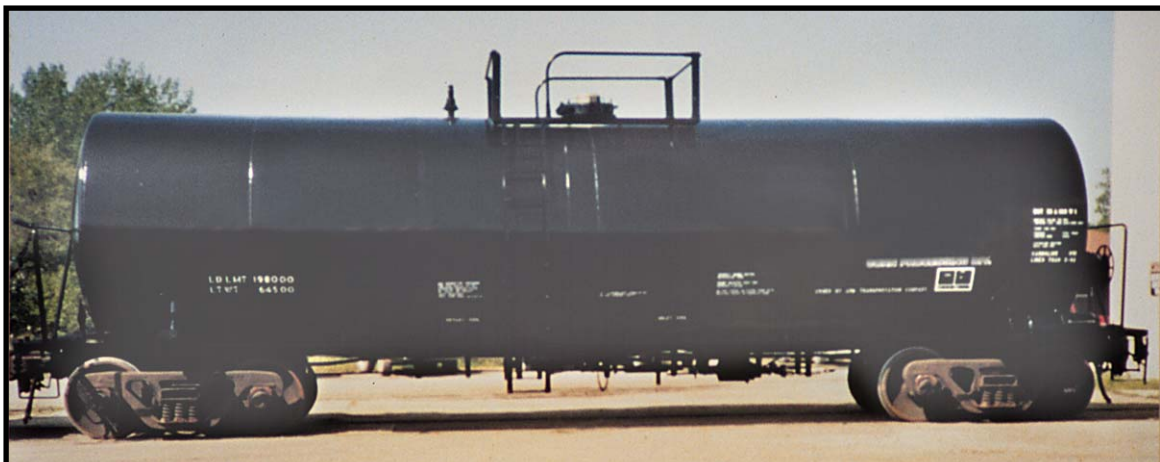
Photo 1 – Side view of similar rail tank car used to transport vegetable oil.

The railroad tank car involved in this incident was transporting soybean oil at the time it was involved in a derailment. A cover gas (nitrogen gas) had been added to the head space (unfilled volume) inside the tank car to prevent spoilage during transport. This is a common practice used by producers of vegetable oils that ship their product by railroad tank car or over-the-road tractor-tanker rigs. After the derailment the soybean oil had been removed and the tank car transported to the company facility for inspection and subsequent repairs. Normally, railroad tank cars like this one, which were filled with a cover gas, would be delivered with a permanent exterior warning sign (i.e. stencil, placard, etc.) affixed to alert workers that a hazardous condition existed inside. Also, company policy required that a temporary exterior warning sign ("red tag" constructed of heavy red paper with wire tie-straps) be affixed to the exterior of such tank cars as an added precaution to insure that workers would be alerted that a hazardous gas or material was inside. Further, a written permit to enter the car was required and additional safeguards were to be followed. This type of hazardous tank car was received infrequently at this facility, this one being the 10th received that year. To the company's knowledge, this was the first tank car received that was filled with nitrogen gas and lacked a permanent exterior warning sign to alert workers.

The railroad tank car involved in this incident did not have a permanent warning sign or stencil on its exterior. Only the wire tie-straps were found still affixed to the exterior of the car. By report, a temporary exterior warning sign (red tag) was affixed to the car after its arrival to the facility. Unfortunately, by the time of the incident this temporary warning sign had been accidentally torn off. In turn, workers assumed the tank car was not hazardous, and did not ventilate the inside of the car. Instead, workers went through their normal routine of opening the top hatch and checking air quality inside before entry. A short time into this process, the first victim told the co-worker accompanying him (attendant) that the air inside was fine, stating it was *"better than the air outside"*, and *"everything is zeros"*. The attendant did not hear any audible alarm from the meter, nor did he recall anything out of the ordinary. Results from these readings were normally recorded on paper forms, however, forms found later that day on a clipboard at the scene, were blank.

Recommendation #5: *Transport containers (i.e. railroad tank cars, over-the-road tractor trailer rigs, etc.) must be marked properly at all times to alert workers of additional hazardous contents and/or conditions.*

Discussion: Ensuring that transport containers or vessels have proper markings or warning signs at all times is an extremely important responsibility that rests with the employer. Further, evaluating a workplace to identify all Permit-Required Confined Spaces (29 CFR 1910.146 (c) (1)) also rests with the employer. Employers should implement programs and procedures to test the air quality inside every railroad tank car no matter if they are marked/tagged/placarded as containing a hazardous environment or not. In turn, the employer should develop redundant methods to ensure railroad tank cars are properly marked and/or tagged at all times during transit, before, and after cars have arrived for refurbishing and/or repair.

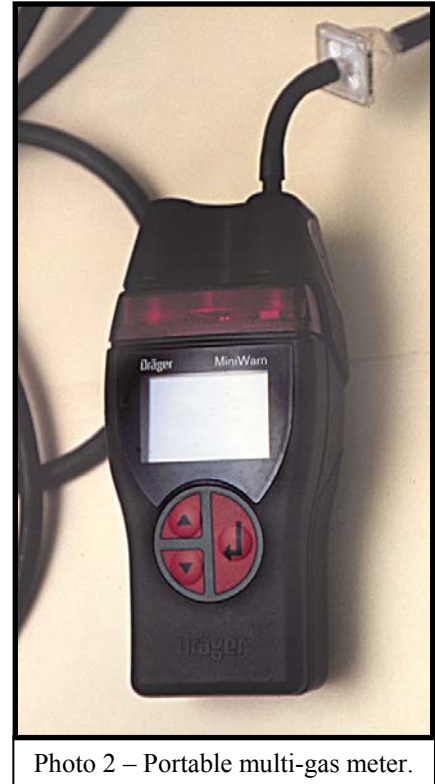
On the day of the incident, the first foreman (first victim) was attempting to assess the extent of repairs from inside the tank car. He used a portable multi-gas meter (see Photo 2) to measure the air quality inside the car, and reported to a co-worker accompanying him (attendant) that the air inside was fine. He then entered the tank car through the top hatch, while the attendant stayed just outside. A short time later, the attendant heard the foreman drop his flashlight, and looking in, saw him lying on the floor of the car. The attendant assumed the foreman must have bumped his head or experienced a heart attack. In turn, he called local emergency response (911), and also radioed for

Photo 2 – Portable multi-gas meter.

The company's portable multi-gas meter that was used by the first victim was tested at the scene by the emergency crew and the county Sheriff. It was found to be in normal operating condition. This testing was begun roughly 10 minutes after the men were removed, in the same railroad tank car. The meter functioned properly, and the audible alarm sounded due to the lack of oxygen. The county Sheriff confiscated the gas meter at this point. A short time later, the same meter was tested at its manufacturer's service and repair facility, and was again found to be working properly.

Recommendation #3: *Employers must insure that workers testing air quality inside confined spaces are trained not only to conduct these tests, but to conduct them regardless of the situation or lack of an apparent safety hazard.*

Discussion: As stated above, the company is responsible for seeing that air quality tests inside tank cars are conducted properly. Had these tests been completed as required by the company's existing confined space program, it is reasonable to assume the portable multi-gas meter would have functioned properly and sounded its audible alarm. These routine air quality tests must be performed on a regular basis as redundant safety measures, even if there is no perceived risk, and employees should be monitored and disciplined for any non-compliance in this duty. In this case, the missing warning sign or placard was coupled with an insufficient air-quality testing protocol, and workers were not alerted to potential hazards.
