FROM: Iowa FACE Program Case No. 21A56 Report Date: 7/22/2003

SUBJECT: Farmer Killed When Tricycle Tractor With Front-End Loader Overturns

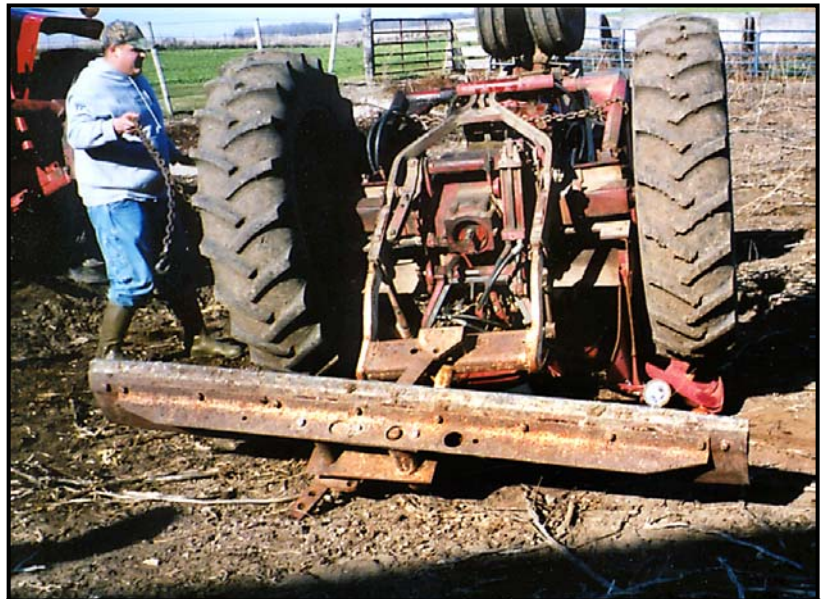
Photo 1 -- Shot of the rear of the overturned tractor, facing north.

The right rear wheel on the tractor was unclamped after the rollover (see Photo 1). There was no damage evident on the rim, and this was not thought to be a factor in this accident. The hydraulic lever to dump the bucket was pushed forward. It is possible that the victim had just activated the lever when the overturn occurred. However, the load of dirt appeared to be still in the bucket during the overturn, and most of the dirt landed under that overturned bucket.

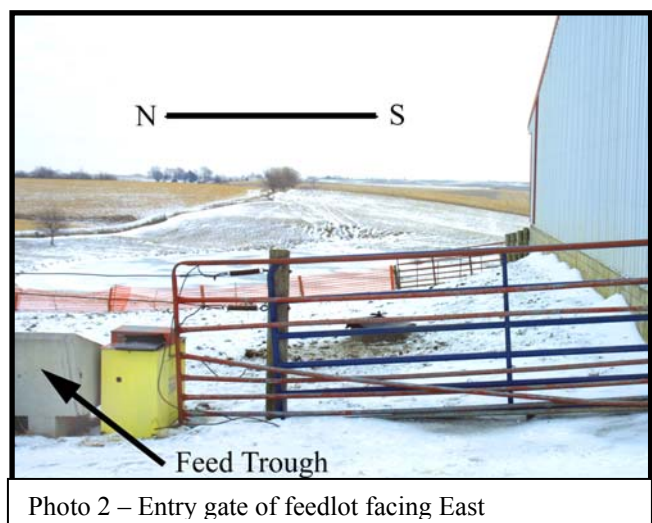
Photo 2 – Entry gate of feedlot facing East

The feedlot was near the farmyard on the north side of the machine shed. It had a long concrete feed trough on its western edge (see Photos 2, 3). Several bucket loads of dirt had already been dumped and spread near the machine shed, and the farmer was dumping and leveling the remainder of the dirt next to the feed trough. Entry into the feedlot was from a gate between the south end of the feed trough and the machine shed (see Photo 2). The farmer had entered the feedlot and turned left towards the feed trough. He was adjacent and parallel to the feed trough at the time of the overturn.

The terrain in the feedlot was soft dirt, and it sloped slightly to the Northeast (see Photo 2). The slope was only a few degrees, and would typically not raise concern about tractor overturn. A relative stated the tractor had routinely been operated in much steeper terrain, and he cannot imagine how the tractor could overturn at this location. He mentioned that if the tractor front end goes over a bump, the hydraulics might “pop or the loader may bang down hard”, but he could not see how this could contribute to this rollover.

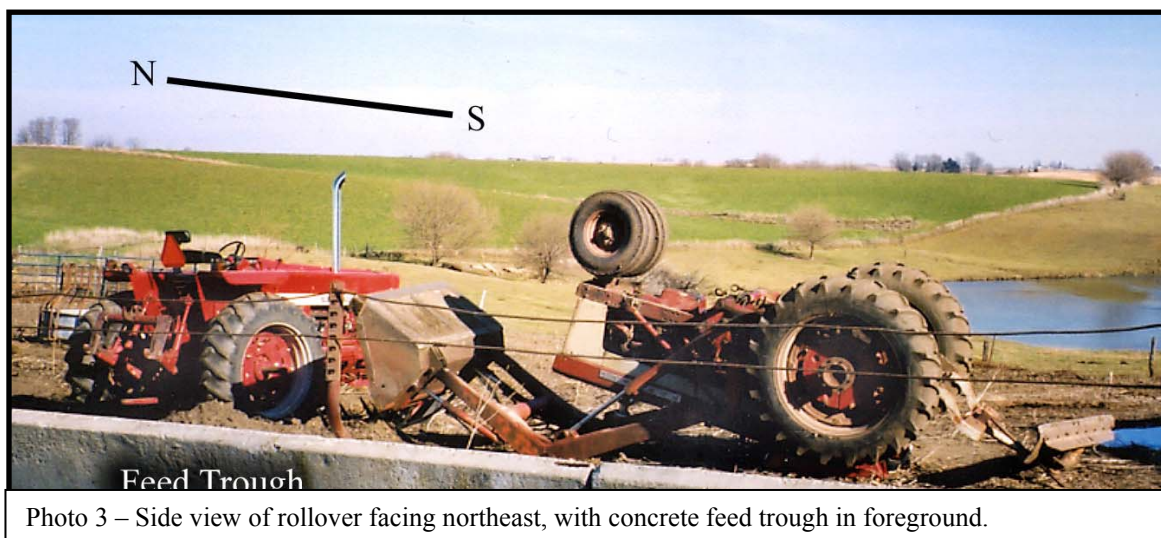
The farmer entered the feedlot with a full load of dirt in the raised bucket. The bucket was slightly higher than the tractor hood after the overturn, and was likely in this raised position also before the overturn. Apparently when he finished his left turn, with the brakes applied, the momentum and speed of the tractor with the raised front bucket were sufficient to roll the tractor to the right, and it continued to roll completely upside down. The farmer was thrown to his left, and was pinned to the ground by a light on the left rear fender.
