FROM: Iowa FACE Case No. 2005IA042 Report Date: 19 June 2007

SUBJECT: Handyman Plumber Asphyxiated in Entry into Water Service Manhole Vault

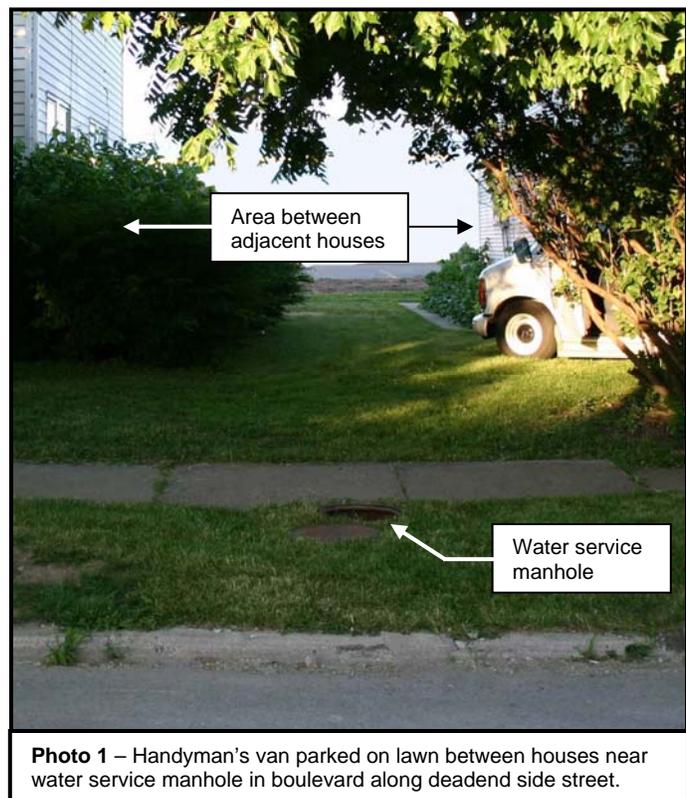
Photo 1 – Handyman's van parked on lawn between houses near water service manhole in boulevard along deadend side street.

The manhole was located along a portion of a dead end side street, in the grass boulevard between the sidewalk and curb (Photo 1). The victim could not easily be seen where he was found. He was headfirst into the opened manhole with the full length of his body in the cylinder of the vault. The weight of his body forced his head to the side against the sandy bottom. Although a neck injury was initially considered a possibility, the autopsy revealed no such injury. His legs sagged limply against the sidewall of the cylinder with the bottoms of his feet just below the ground-level opening of the manhole.

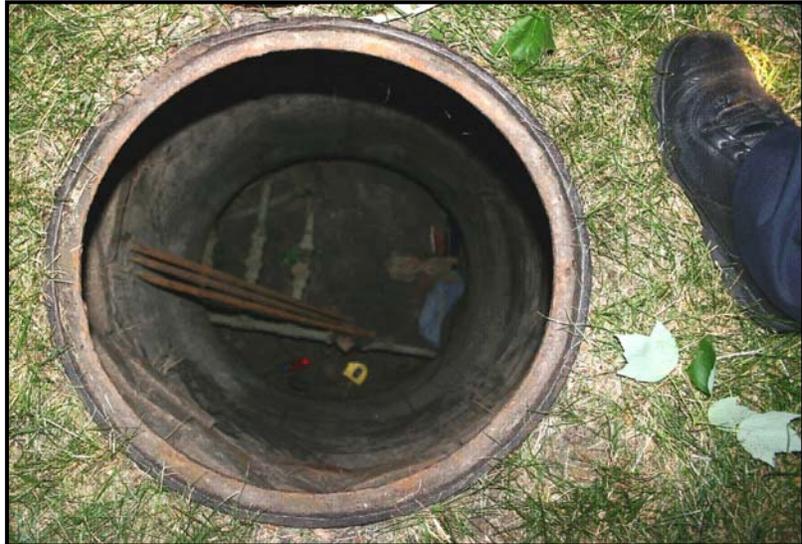
Approximately 175 mm (7 in) up from the sand floor, midway up in the flared-out bottom zone, a 25 mm (1 in) diameter water line ran horizontally, a little off of center, across the pit (Photo 2). Connected to this supply line were three water lines, one for each house served on that side of the street. Each water line had an inline shutoff valve. The private company supplying water for the city did not own nor did they lease this service manhole from the property owners. Hand tools (rods with tools attached to their ends) to operate the shutoff valves without entering the manhole were propped within reach against the side of the cylindrical shaft.

Photo 2 – Shutoff valves at bottom of manhole vault controlled the supply of water to adjacent homes. Tools for operating them lean across the entry way.

The water valve to the residence experiencing the water leak had been turned off prior to the repair work. The victim completed the repair work and returned to the manhole, knelt next to its opening, leaned over and down into it blocking ambient light. It appears he was not using the hand tools stored in and propped against the side of the manhole to operate the valves. A flashlight, screwdriver, and the keys to the residences were found on the surface of the sand at the bottom of the pit.

It is not known whether the victim was stretching his reach down toward the water lines to free a stuck valve, retrieve an object, or to perform some other task and then became stuck, unable to maneuver himself up out of the manhole. Nothing was found (such as a string) to indicate he planned to lower items to the floor of the pit or that he was attempting to retrieve such items, if they were dropped, from a position outside the manhole's entry plane. Neither foul play nor adverse, transitory environmental conditions are suspected. Headfirst, part way into the manhole, the victim lost consciousness and slumped into the position in which he was found.

Next, when the confined space cannot be eliminated, consideration should be given to enabling completion of the task from outside the confined space. Hand tools were provided to operate the water control valves in this incident without entering the manhole pit. The reason these tools were not used is unknown. Signage informing of the potential hazard, procedures to follow, and location of tools to be used should be considered for posting outside the closed manhole.
