THE UNIVERSITY OF IOWA
Iowa City, Iowa 52242

FROM: Iowa FACE Program

SUBJECT: Construction worker crushed between falling dump box and truck frame.

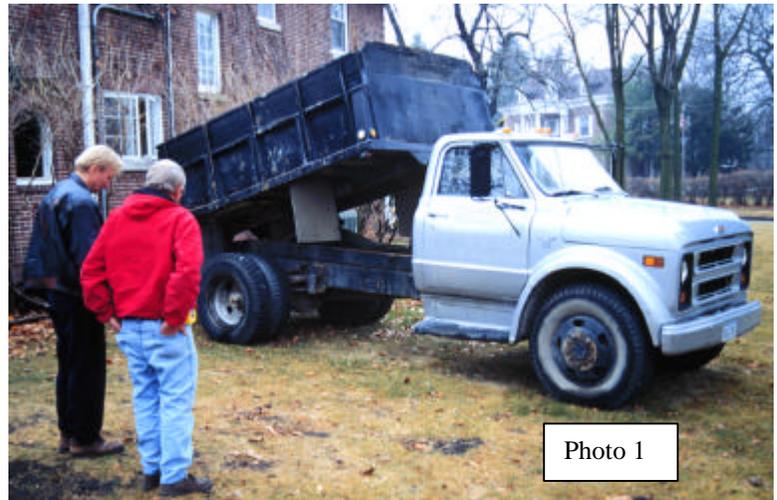
During the fall of 1999, a 53-year-old construction worker was killed after he unloaded sand from a dump truck. He partially raised the box of his truck to dump out a portion of wet sand at a work location, then leaned under the box to manually trip the hydraulic linkage to bring the box down. The hydraulic linkage was located at the hydraulic pump, behind the cab between the main frames of the truck. This action

was apparently a habit to save some time from walking around the truck to push the dump lever inside the truck cab. However, this time, because of the heavy load of sand, and because the box was only partially raised, the truck box came down immediately pinning the man between the box and the frame of the dump truck. The man suffered massive head injuries and was dead at the scene. The deceased truck driver had several years of experience with machinery and was the lead man for the small construction company.

- *Workers should use proper machine controls rather than actuating machine functions at hazardous locations.*
- *Employers should train and supervise workers adequately to ensure that safe procedures are followed.*
- *Manufacturers of dump trucks should consider options to discourage unsafe use of dump box hydraulics, such as placement or shielding of controls*

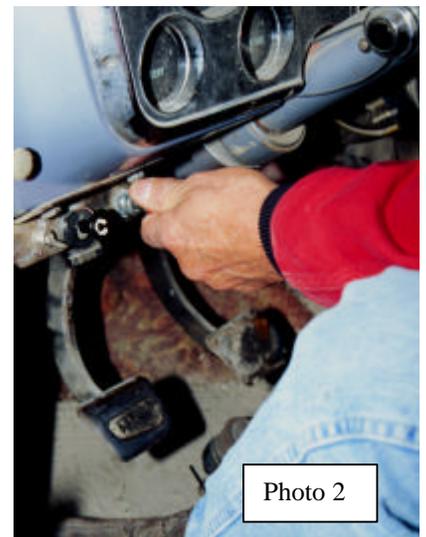
The dump truck was a 1968 model with a payload of seven tons. It was maintained by the victim and was in normal operating condition. The hydraulically-controlled dump box was actuated by a hand-operated knob inside the cab of the truck (see Photo 2), and controlled by the clutch pedal. A cable ran from the knob to a hydraulic valve located between the main frames of the truck (see Photo 3). When the box was raised, this cable end and actuator lever at the hydraulic pump housing were visible and within easy reach.

Discussion: The hydraulic linkage in this older dump truck was easily accessible from the sides of the truck when the box was raised. While this is an unexpected hazardous behavior, it might be possible to prevent such behaviors by placing the linkage where it cannot be easily reached or enclosing the linkage so that it could not be easily misused.

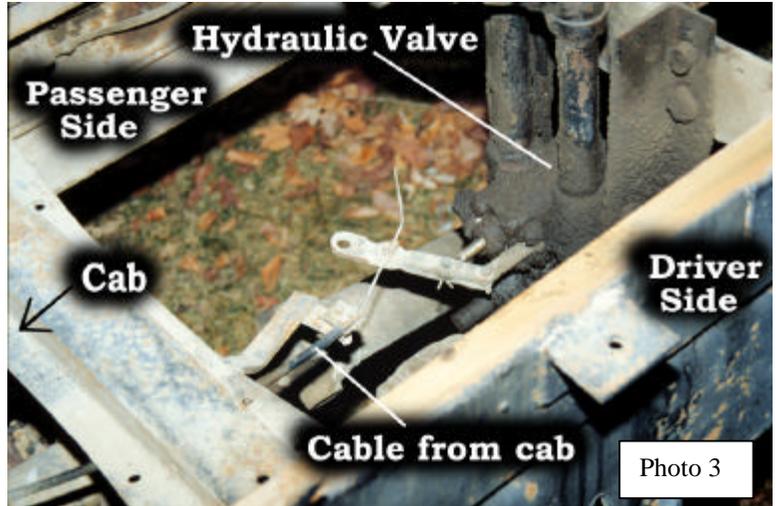
The victim partially raised the box of his dump truck and unloaded about 1/3 of the load of sand, which was wet and heavy. Then while standing and leaning in from the passenger side of the truck, he manually tripped the hydraulic control lever to bring the box down. However, due to the weight of the wet sand and the low height of the box, it slammed down immediately and pinned the man to the frame of the truck. He was killed instantly from severe head injuries.

Apparently the victim had lowered the truck box manually before instead of using the cable control inside the truck cab. Co-workers who witnessed him lowering the box in this manner at other job sites confirmed this. When the box was fully raised and the load was completely dumped, the box would descend slowly and he would have ample time to get out of the way. The victim had worked with this company for the last three years and probably had lowered a partially-raised truck box in this fashion many times. It is not clear whether he might have slipped, lost his balance, or got caught by his clothing, preventing him from escaping.

Discussion: The victim was in the process of dumping a partial load of wet sand. It appears he had developed a system of monitoring how much had been dumped by standing to the side of the dump truck, then at the proper time, manually releasing the dump box hydraulic lever to bring the box back down. This was probably a more accurate method of measuring how much had been dumped, rather than using the controls in the truck cab. In many cases the workers would be working alone, so it may not be possible to ask other workers to monitor and signal when the box should be lowered. This method had reportedly been used before, but on this day, perhaps because of the wet sand and the lower position of the box; the box may have fallen much faster. It is not known whether he slipped or got caught while trying to move out of the way of the falling truck box. However, during demonstrations, the box descended very fast giving little time to escape in a similar situation. Since the event was unwitnessed, the details of this accident will never be fully known. However, it is clear that actuating the hydraulics under the raised box is hazardous and should not be done in any circumstances.
