Iowa FACE Report: Farm worker electrocuted while pressure-washing interior of swine barn
Case ID: 2008 IA 074
Date: 5 December 2014

The victim was a native of Honduras who had worked in the US for several months before moving to the local area. The incident occurred on his sixth day of work.

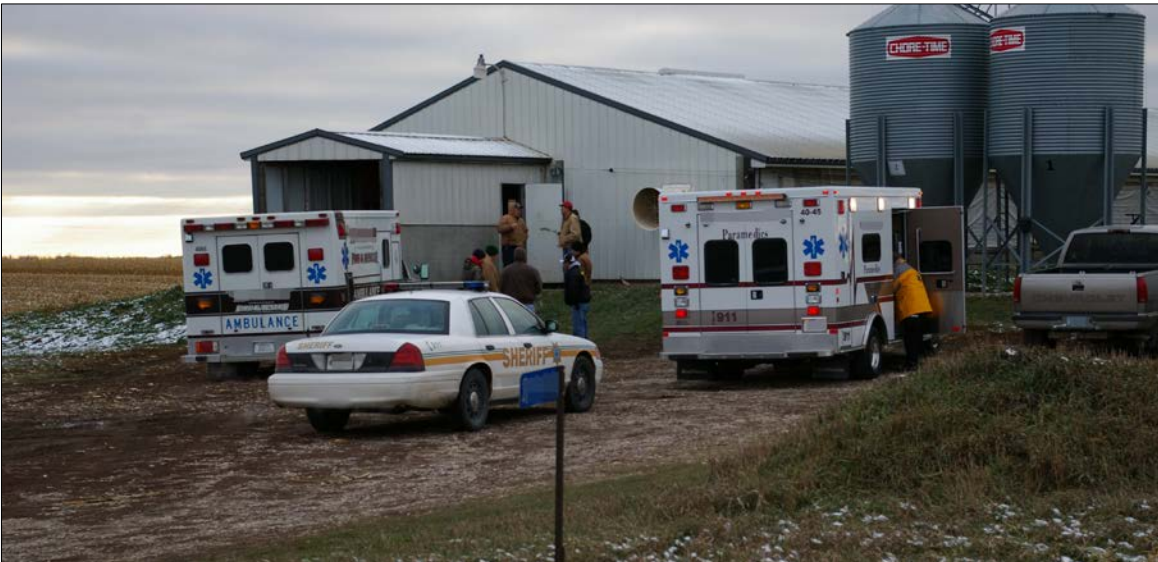
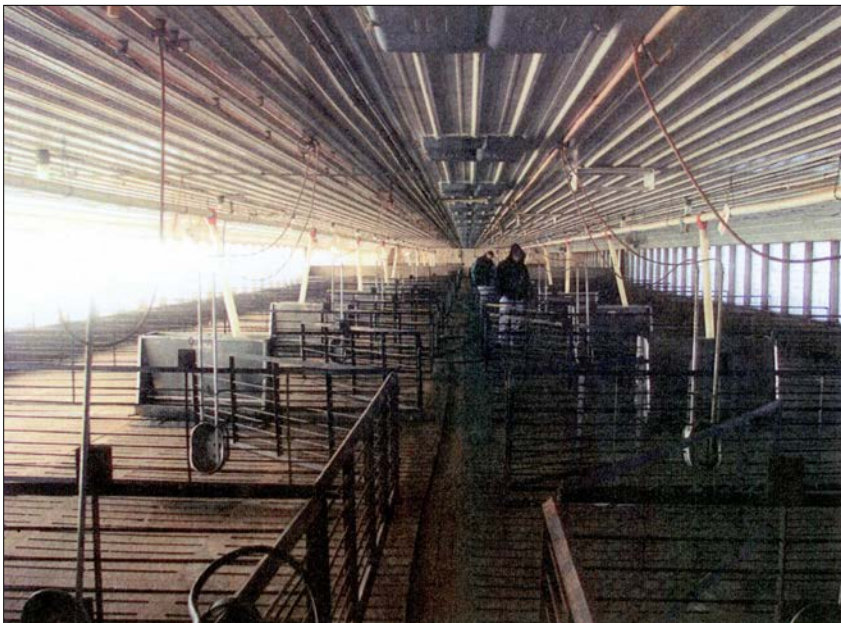
The main electrical service panel and breaker were located on the exterior of the building. The licensed electrician who evaluated the electrical installation as part of the IOWA fatality investigation determined that the electrical circuits were properly wired and grounded.

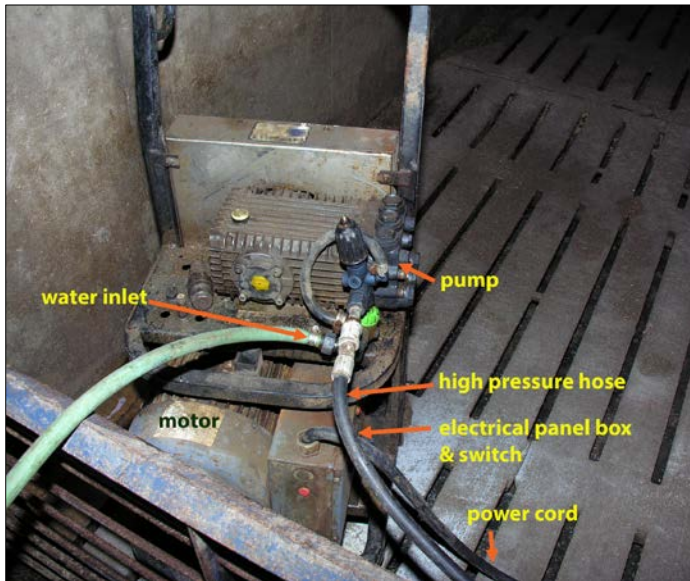
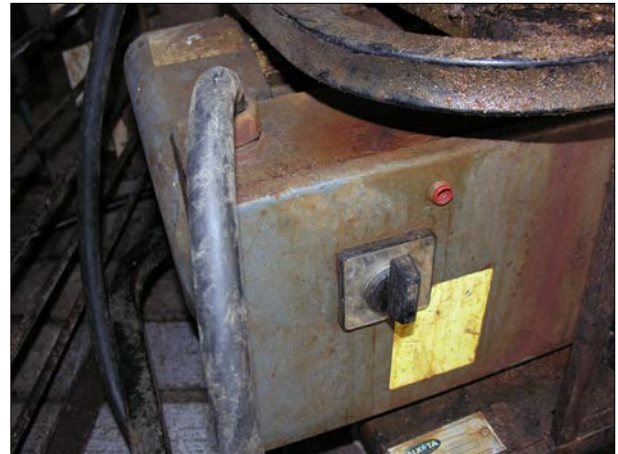
E. Cover of electrical panel box replaced in inverted orientation (above)

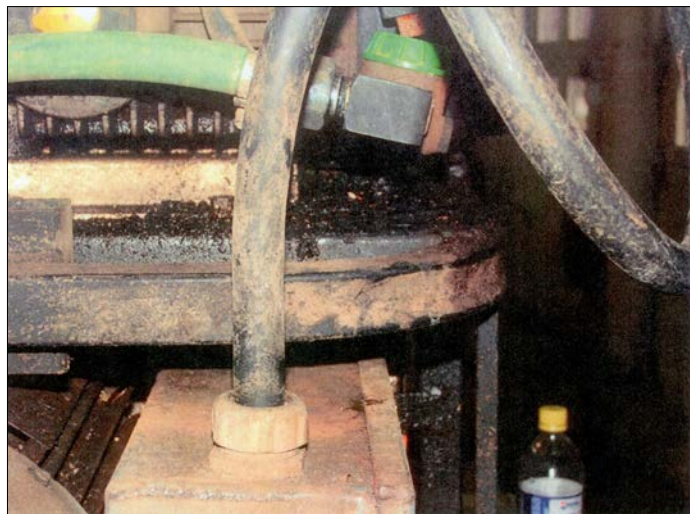
D. Water inlet located above electrical panel box (2 photos above)

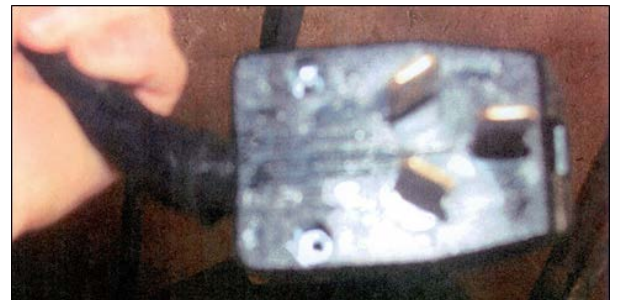
F. Replacement plug at end of pressure washer power cord

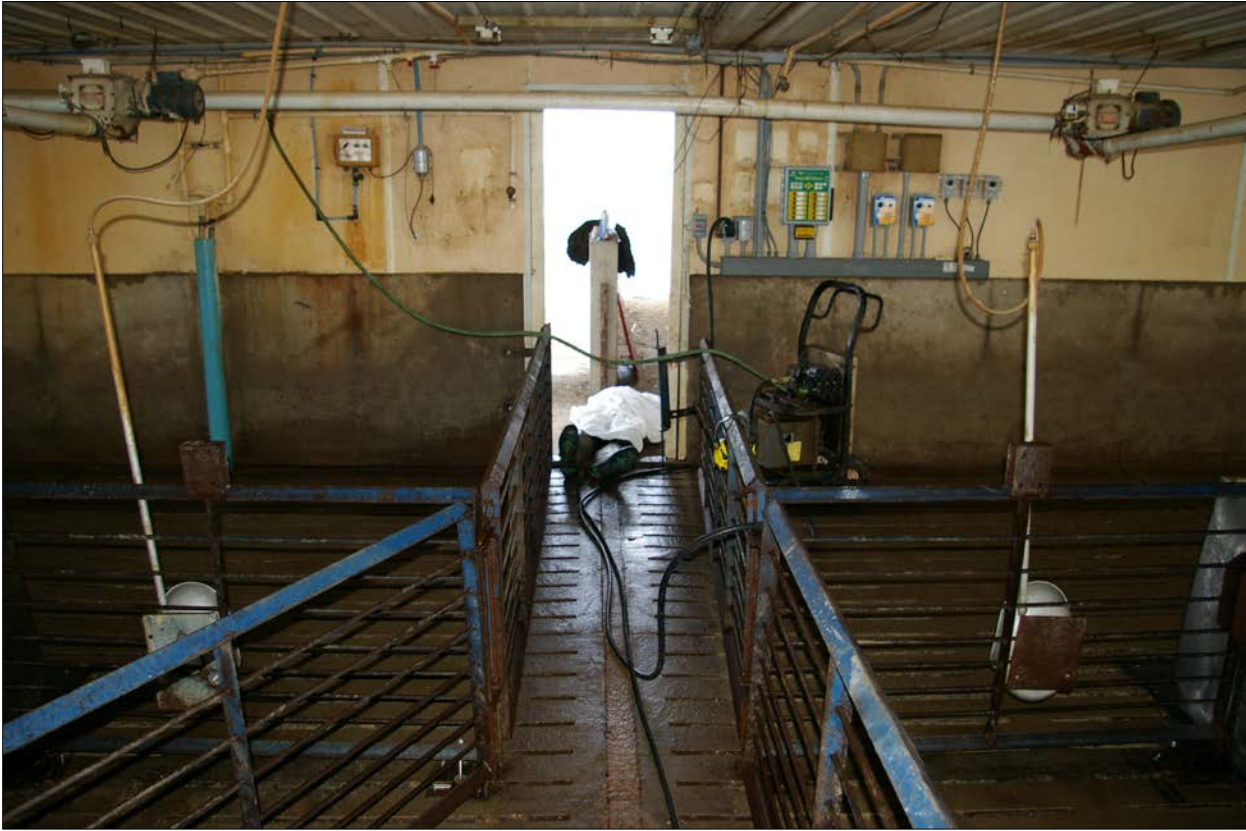
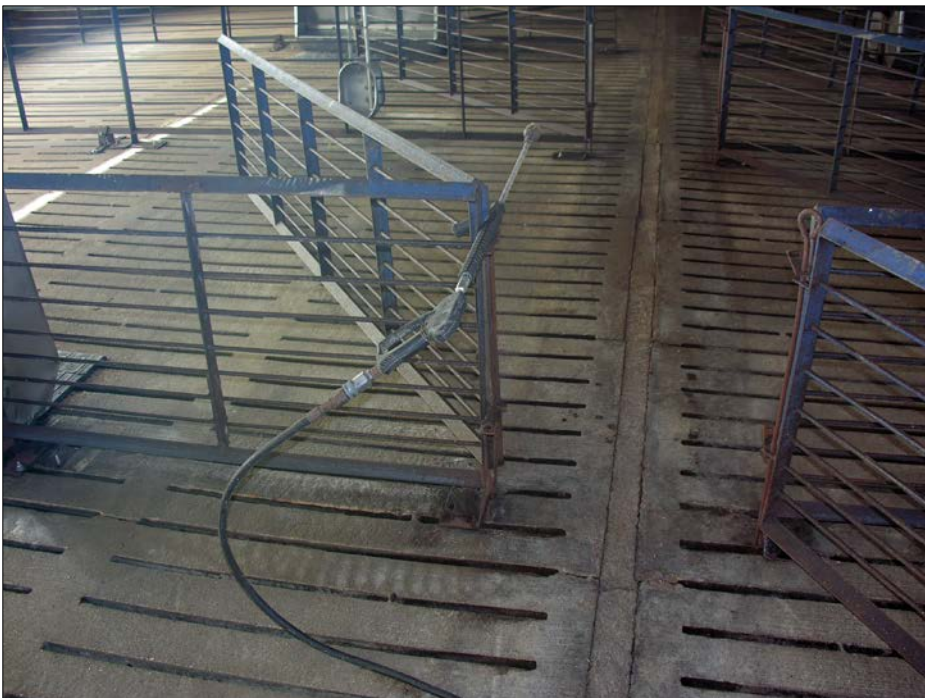
G. Scene inside the building (above and at left). Victim had been moved to loading dock area.

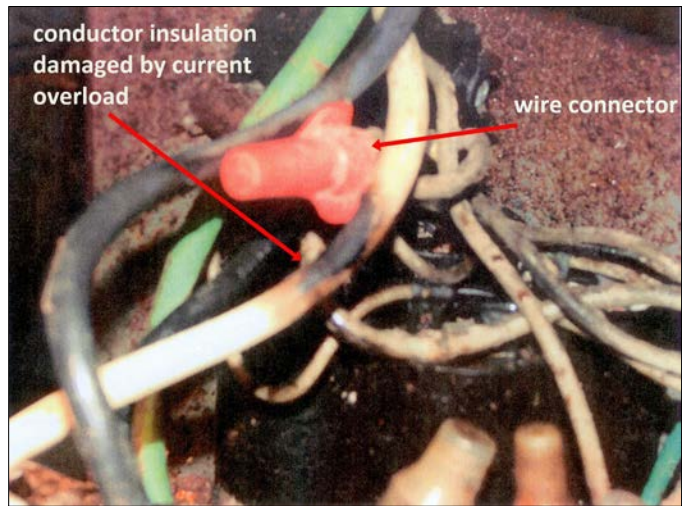
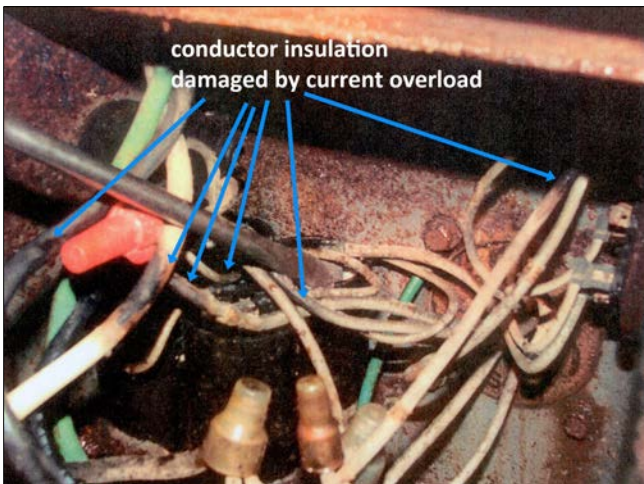
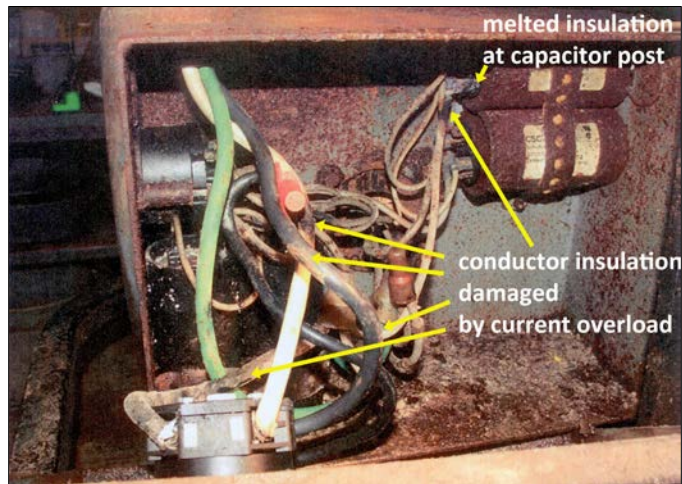
H. Interior of electrical panel showing corrosion and heat damage to insulation (3 photos above)

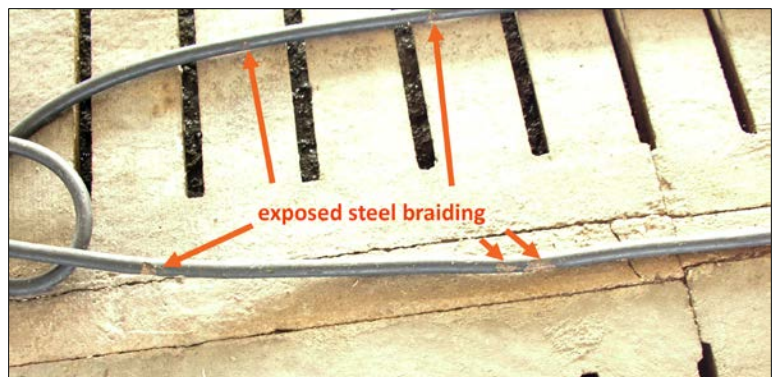
I. Damage to insulation of high pressure hose (at right)

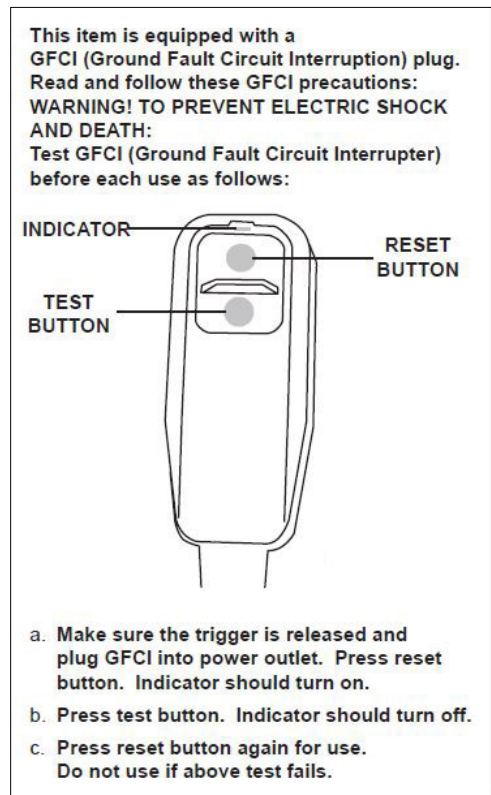
⁹ However, if the person also happened to be in contact with a grounded object in either of these circumstances, the GFCI would detect the imbalance in current and open the circuit.
