THE UNIVERSITY OF IOWA  
Iowa City, Iowa 52242

**TO: Director, National Institute for Occupational Safety and Health**

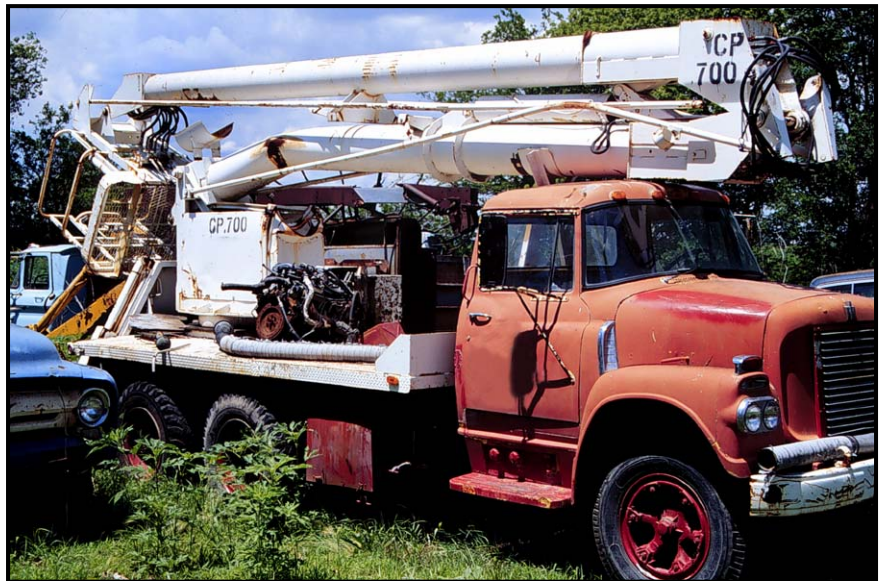
Photo 1 -- View of boom truck as it sits in a junkyard. The bend in the lift arm occurred when the machine fell to the ground.

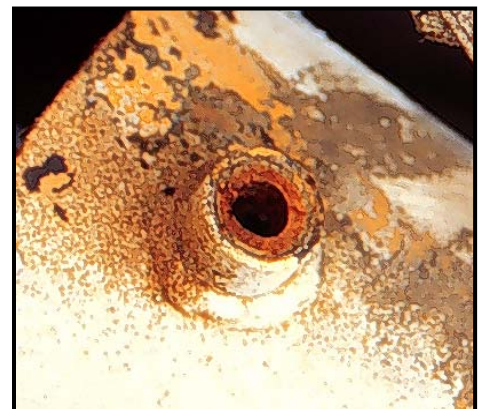
Photo 3 -- Hydraulic line input showing broken edge of nipple. Photo taken several months later shows significant additional rusting.
