TO: Director, National Institute for Occupational Safety and Health

FROM: Iowa FACE Program

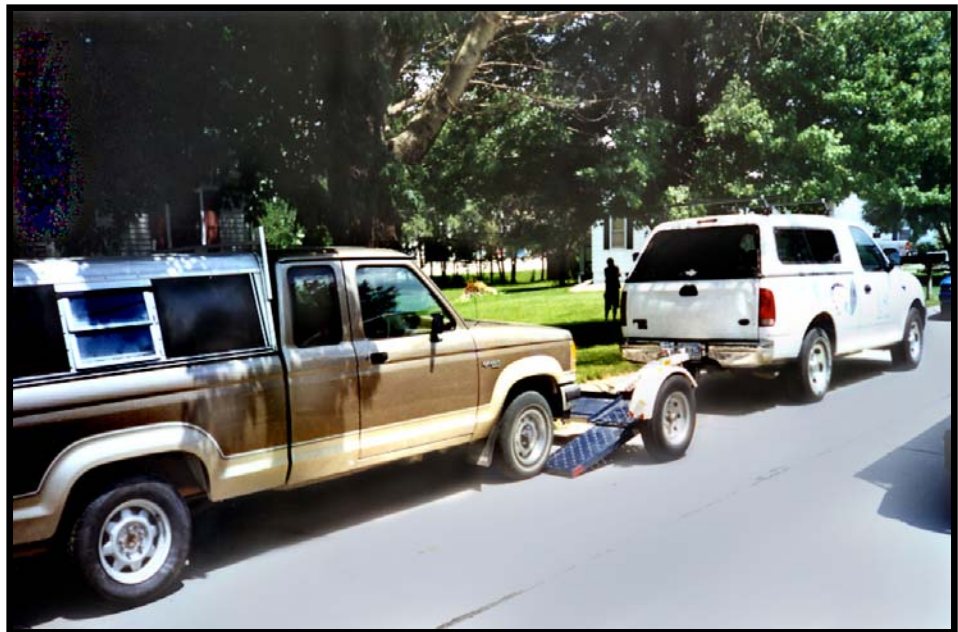
Photo 1 – Side view from the street showing both trucks and the 2-wheeled dolly.

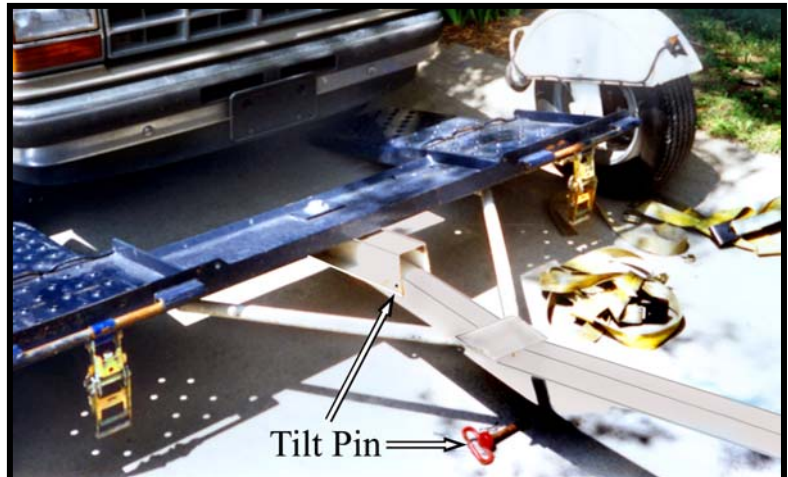
Photo 3 – Front view of tow dolly showing tilt pin removed and ramp tilted downward. (Photo enhanced for clarity)

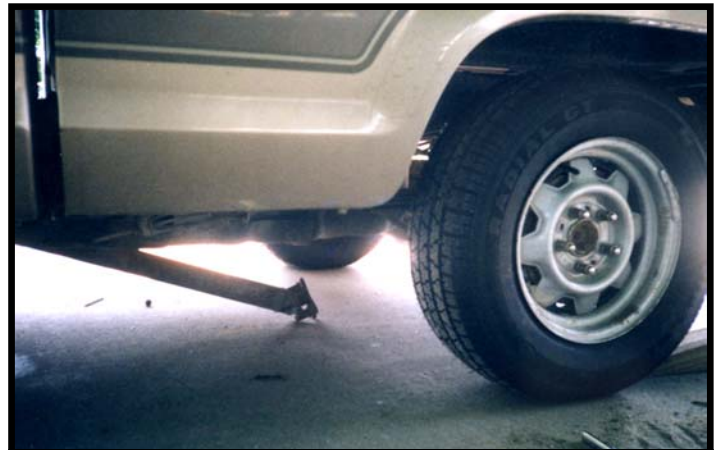
Photo 4 – View from driver's side of the vehicle-in-tow showing the driveshaft disconnected from the differential.
