THE UNIVERSITY OF IOWA
Iowa City, Iowa 52242

TO: Director, National Institute for Occupational Safety and Health

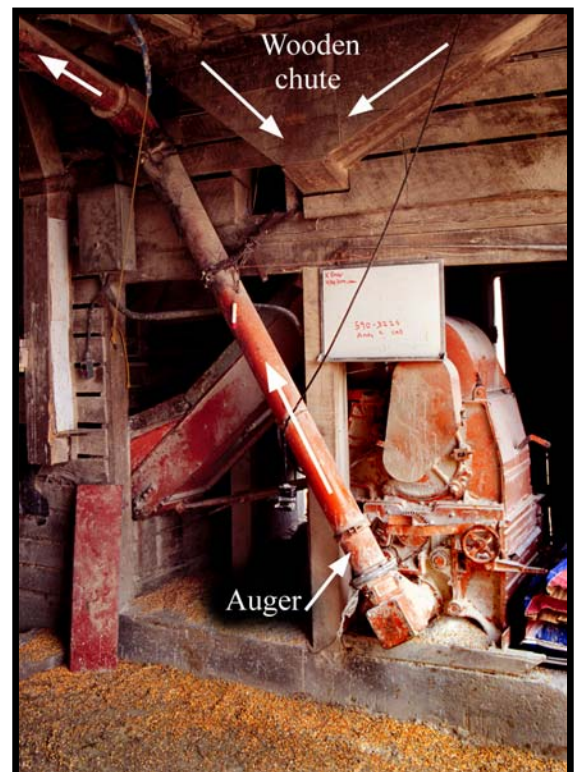
Photo 1 -- View of roller mill from inside the corncrib showing gravity-fed chute and auger.

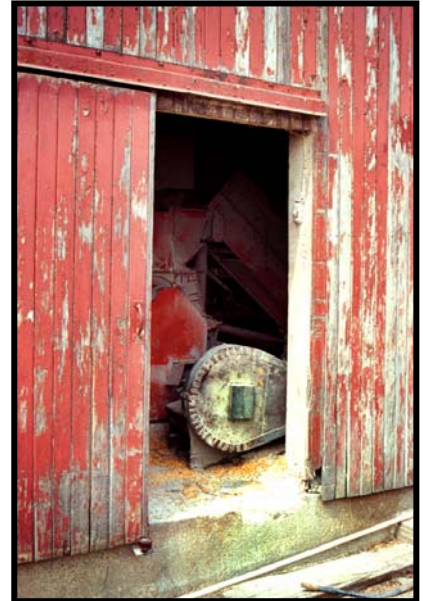
Photo 2 -- View of corner crib door with mill immediately inside.

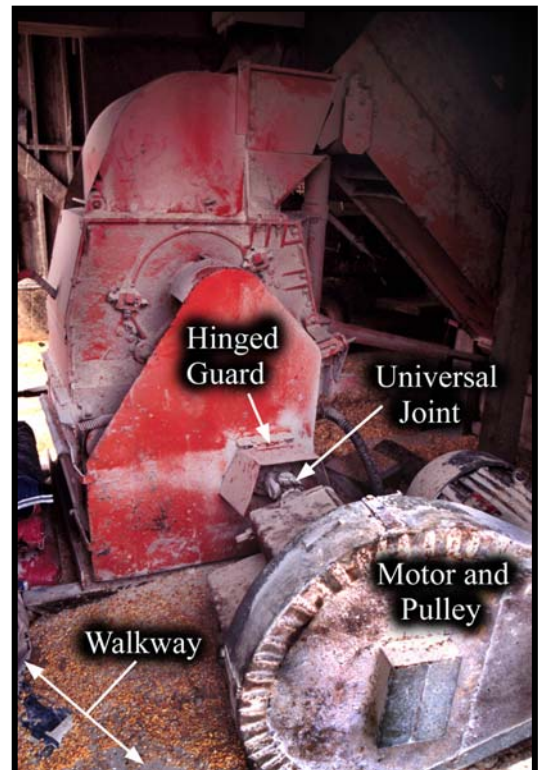
Photo 3 -- Mill as seen from side doorway.

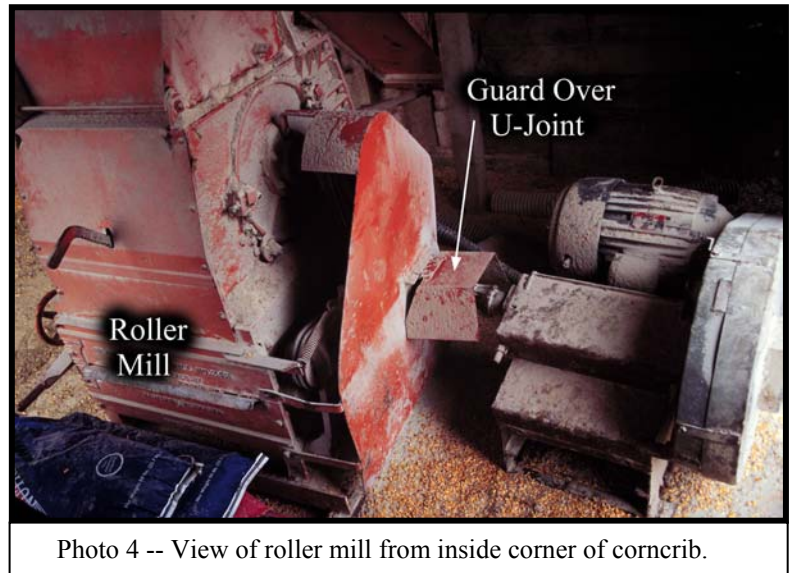
Photo 4 -- View of roller mill from inside corner of corncrib.

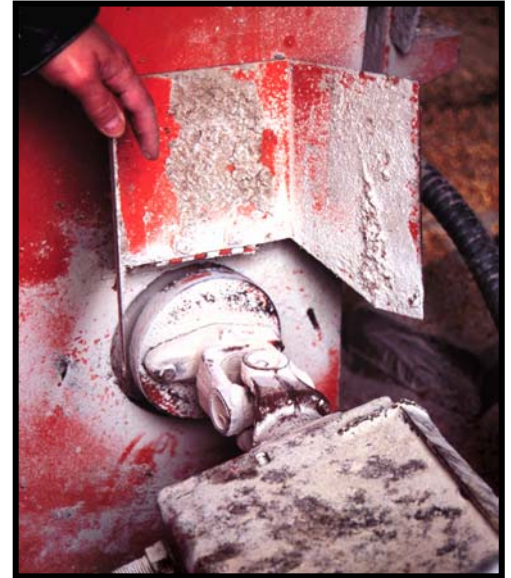
Photo 5 -- Close-up of universal joint and flimsy guard hinged above it.
