TO: Director, National Institute for Occupational Safety and Health

FROM: Iowa FACE Program

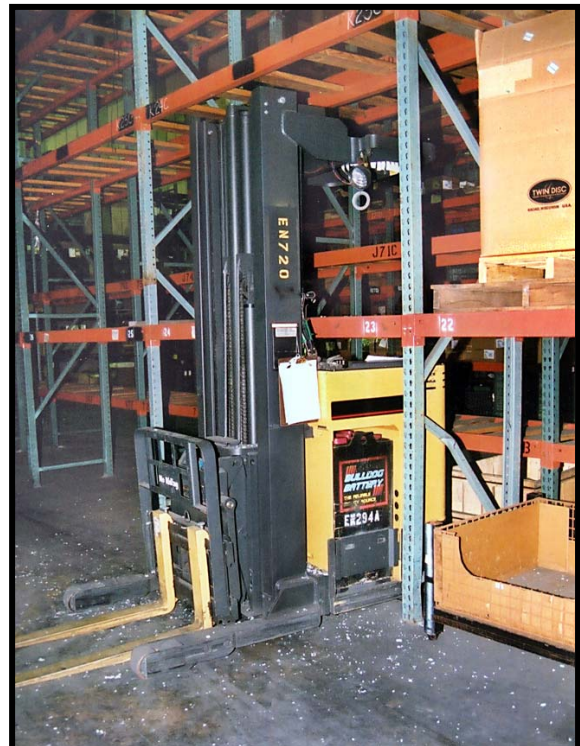
Photo 1 – Left-front view of the forklift, positioned as it was found under the empty metal rack beam.

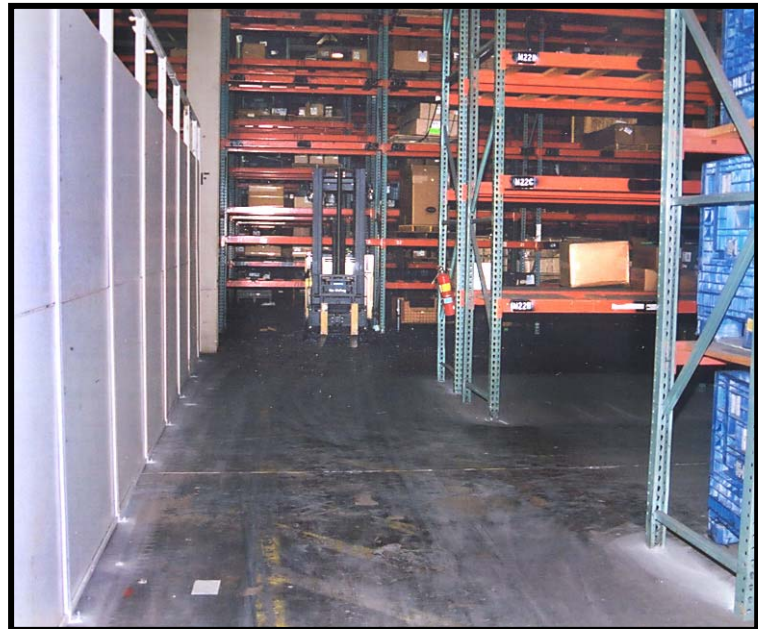
Photo 3 – View from the front of the forklift, showing the aisle ends and the wall to the side.

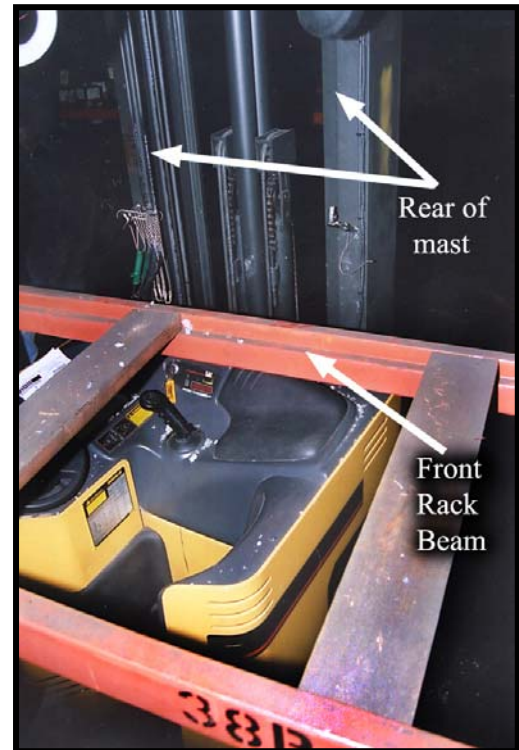
Photo 4 – View from behind the rack beam showing the operator's work area, machine controls on the console, and the unprotected rear corner of the machine.
