FROM: Iowa FACE Case No. 2010 IA 005 Report Date: 10 October 2012

SUBJECT: Special-needs sanitation route helper caught in tailgate of waste collection truck

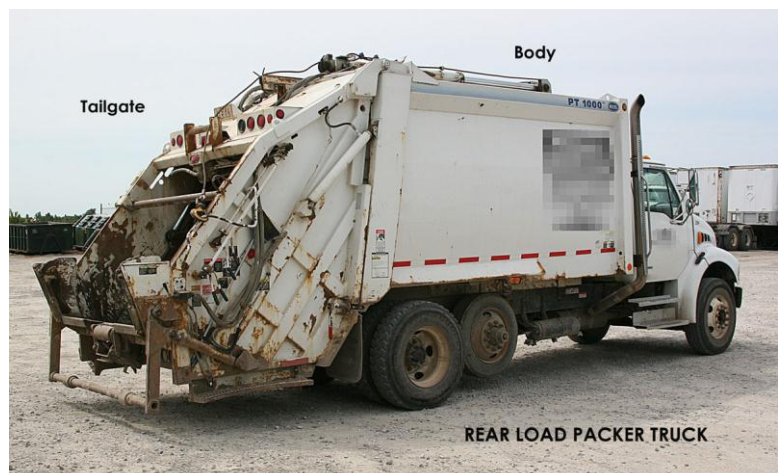
The victim and his partner conducted their pickup route in a 2004 rear load packer truck with 20 cubic yards capacity (Exhibit 1). On a rear load packer, the helper manually lifts and empties individual trash containers - or cardboard - into a 3-cubic-yard hopper in the tailgate of the truck. A hydraulic packer panel in the tailgate compacts the hopper contents and pushes them into the main body of the truck.

Exhibit 1: Rear load packer truck involved in incident

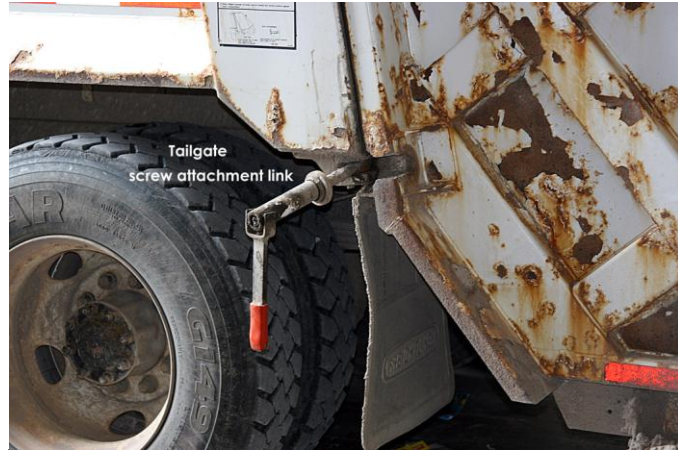
To unload the truck, two locking screw attachment links must be unsecured manually. The attachment links are located on the driver and passenger sides of the truck between the tailgate and main body (Exhibit 2).

Exhibit 2: Attachment link that secures tailgate in closed position

Recommendation 5. *Specify that only drivers are authorized to unsecure tailgate latches and operate tailgate mechanisms.*

Discussion: Prior to the fatality, helpers may on occasion have assisted drivers in unloading procedures at the recycling center. Following the incident, drivers were instructed that only they are authorized to prepare and operate their truck tailgate for unloading. With only drivers having authority to unsecure both tailgate latches, there is no need for helpers or other employees to be in restricted areas out of the driver's or spotter's line of vision, reducing the potential risk of their being injured by moving equipment.

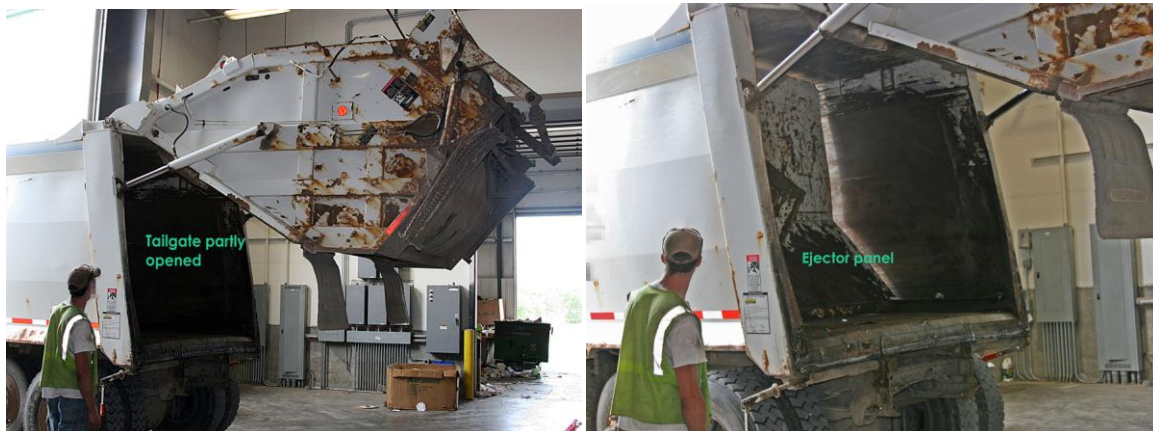
After the links are unsecured, the driver operates hydraulic controls that raise the entire tailgate, swinging it upward (Exhibit 3). The hydraulic tailgate controls are located on the exterior of the truck to the rear of the driver side of the cab. A vertical hydraulic ejector panel inside the front body of the truck then pushes contents out the back of the truck (Exhibit 3).

Exhibit 3: Rear-load packer truck with tailgate opened and ejector panel fully extended

Recommendation 6. *Require drivers to follow defined protocols for removing lodged materials from truck bodies or hoppers. These include using tailgate props to secure the tailgate in a supported open position, and shutting off the ignition and pocketing keys prior to clearing the tailgate or rear body of the truck.*

Discussion: Drivers must use lockout practices to safeguard against equipment starting or releasing hazardous energy. When it is necessary to clear material from the tailgate or truck body at the recycling center or landfill, drivers must now either a) enter the front of the truck body through an access door behind the cab, or b) use tailgate props which are standard equipment on the vehicles to support the opened tailgate in a fixed position with the engine off. In both instances, clearing the truck of lodged material is done only after the truck ignition has been turned off and the driver pockets the keys. This policy assures that the truck controls cannot be engaged, that the risk of injury from a moving tailgate is minimized or eliminated, and that *drivers only* are authorized to clear lodged materials.

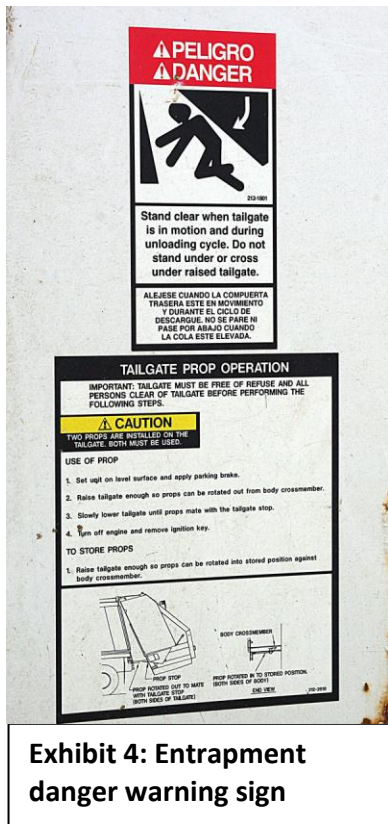
After the contents are emptied, the tailgate must be lowered to a closed position and the tailgate attachments must be re-secured. When the tailgate is in any position other than fully closed, an audible alarm sounds until the tailgate is returned to fully closed position. The sound of the alarm does not change based on the movement or position of the opened tailgate. Signage is present on both sides of the truck to the front of the tailgate warning of the danger of being caught or struck by the tailgate (Exhibit 4).

Exhibit 4: Entrapment danger warning sign

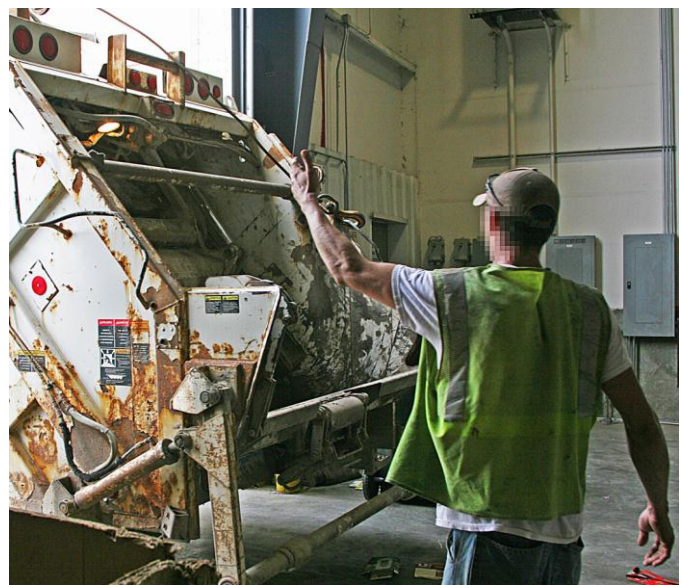
Discussion: The company implemented a new policy after the fatality requiring that all truck traffic into the facility be directed by spotters. Several recycling center employees were designated and trained as spotters. Drivers waiting to unload must wait outside the facility for a spotter to direct their truck into the building. Spotters assure that all persons are clear of the restricted area during unloading. Spotters give drivers clearance to proceed with all unloading activities and maneuvers using standard hand signals. They direct the driver in entry and exit from the facility, raising and lowering the tailgate, and ejection of a load (Exhibit 5). Spotters assure that only drivers operate latches and controls involving tailgate movement.

Exhibit 5: Spotter using hand signal to direct truck into recycling center

Recommendation 2. *Designate trained spotters to direct drivers entering, unloading, and exiting facilities where other employees or bystanders may be present.*
