FROM: Iowa FACE Case No. 2010 IA 054 Report Date: 10 October 2012

SUBJECT: Construction laborer fell from ladder

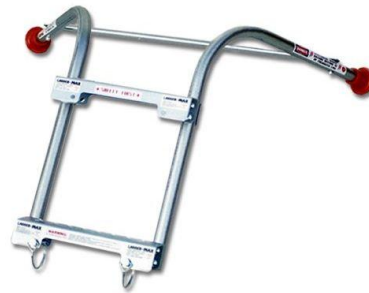
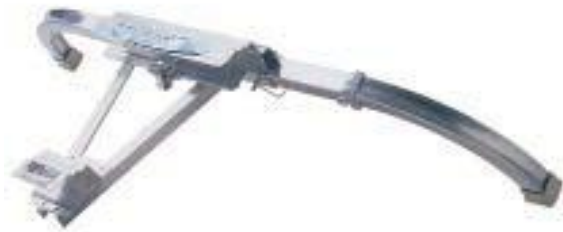
Exhibit 2. Examples of ladder stabilizers

approximately 3 feet beyond the roof eaves. The ANSI duty rating of the ladder was not known. A stabilizer bar (Exhibit 2) was affixed to the upper section of the ladder with pins and clips. A nylon tie-down strap (Exhibit 3) attached to the stabilizer bar was screwed onto the roof deck to secure the top of the ladder in position. The type and size of the tie-down strap and the screw used to secure the strap to the roof was not known. The bottom of the cleated ladder rested on dry level ground of earth and gravel, but was not staked to the ground or secured to a permanent fixture.

Neither the owner nor the coworker witnessed the helper fall, but the owner noted that in the course of the fall, the nylon tie-down strap broke and that one end of the strap still remained screwed to the roof deck. The stabilizer bar had come free of the ladder. There were grooves in the earth approximately one-half inch deep and several inches long where the ladder cleats slid sideways. The ladder itself was not found to be faulty. The owner suspected the victim lost his balance as he put the tarp on the roof or shortly thereafter and may have tried to jump to the elevated area next to the foundation retaining wall. No information was available regarding the victim's footwear or whether his footwear played a part in the fall.

In this fall, the stabilizer came free of the ladder when the single nylon tie-down strap broke. A more secure fixture would have been to use appropriate-strength rated nylon straps (selected according to safe load limit and breaking strength) to affix the top end of each ladder rail to the roof. The ladder should also have been secured at the bottom, by tying or staking both bottom rails to the ground or to fixed structures (Exhibit 5). Securing the ladder at the bottom as well as the top may have prevented this ladder from lateral movement if the victim reached or leaned to the side while climbing or placing the tarp.

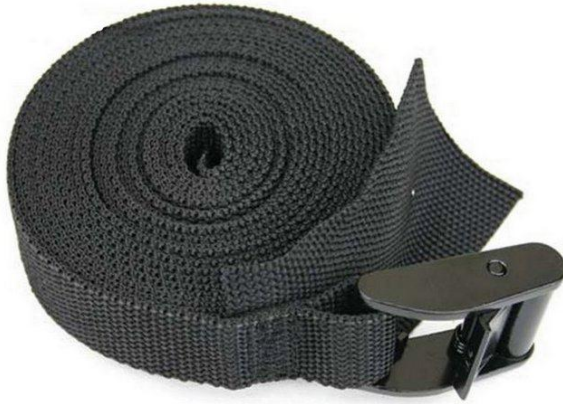
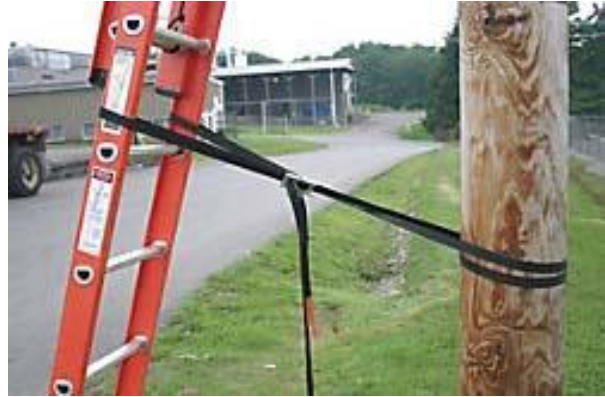
Exhibit 3. Examples of tie-down straps, not specific to this investigation

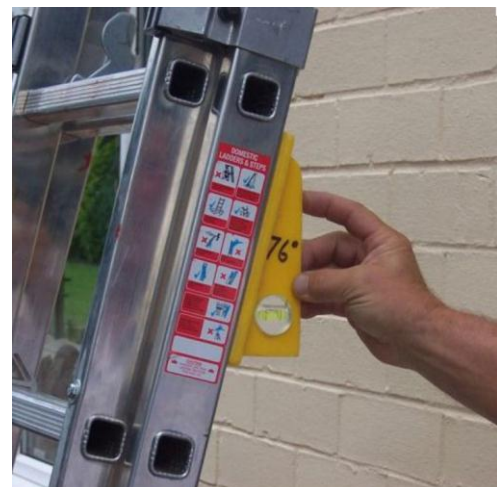
Exhibit 4. Proper height-to-base ratio and ladder angle to set up portable extension ladders

Non-self-supporting ladders leaned against a wall or other support should be positioned at an angle such that the horizontal distance from the support to the base of the ladder is one-quarter the distance of the vertical height of the ladder (i.e., the angle of the ladder should be about 75° to horizontal, Exhibit 4). If the ladder is too close to the building (too steep an angle) the ladder may tip backward; if it is too far from the building, the ladder may be put under greater stress than it was intended to handle, and ladder may slip out at the bottom.
