**FROM: Iowa Fatality Assessment and Control Evaluation (FACE) Program**

**DATE: June 2000**

**SUBJECT: Sanitation assistant crushed between garbage truck and compactor**

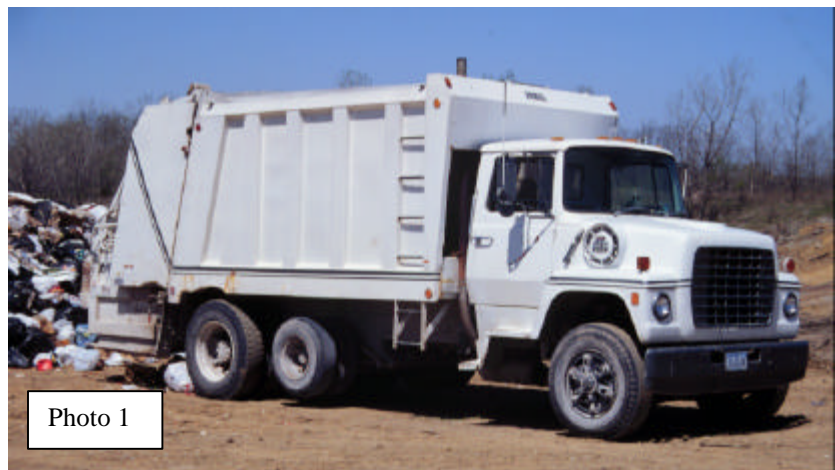
A 30 year-old male sanitation assistant (the victim) was crushed by the hydraulically powered tailgate of a garbage truck while unloading garbage at a county landfill. The truck operator and the victim had just finished unloading their garbage truck, lowered the tailgate to the 3/4 closed position and had

cleaned the tailgate latching screws. Before the tailgate was fully lowered, the operator alerted the victim, by saying "stand clear" and the victim responded accordingly. The tailgate was then lowered by the operator using controls on the driver's side of the truck, out of sight from the victim on the opposite side of the truck. When the operator walked to the passenger side for a final check, he found the victim lying on the ground with significant head injuries. His head had been caught between the frame of the truck and the tailgate as it was closing. The operator and a bulldozer operator called 911 for assistance. The County Sheriff, his deputy, and ambulance personnel arrived at the scene within minutes. The county medical examiner was notified, responded, and pronounced the man dead at the scene. The truck was found to be in normal operating order. A discarded fishing pole was found inside the garbage compartment of the truck, and it is possible that the victim was trying to retrieve this item immediately prior to getting caught.

- 1. Safety work practices should be re-emphasized with all employees, and in particular, with part-time employees.*
- 2. Employers should ensure that a job safety analysis has been performed on all work-related tasks.*

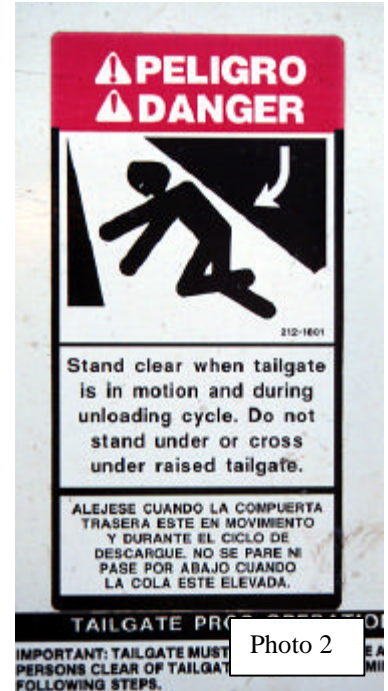
A 30-year-old male was crushed between the frame of a garbage truck and the hydraulic compactor after unloading at a landfill site. A warning sign was posted on the passenger's side of the truck stating "*Stand clear when tailgate is in motion and during unloading cycle*" (see Photo 2). Environmental conditions were not a contributing factor.

**Discussion:** In this situation, verbal instruction was provided on the unloading process, and a sign was posted on the passenger's side of the truck to confirm this. It stated, "*Stand clear when tailgate is in motion and during unloading cycle*". In addition, employees should be reminded of the importance of safe work practices and the consequences of using hydraulic equipment. During our investigation, while the hydraulic compactor was moving, we instinctively stood clear of the truck, aware that the heavy hydraulic components could cause serious injury.

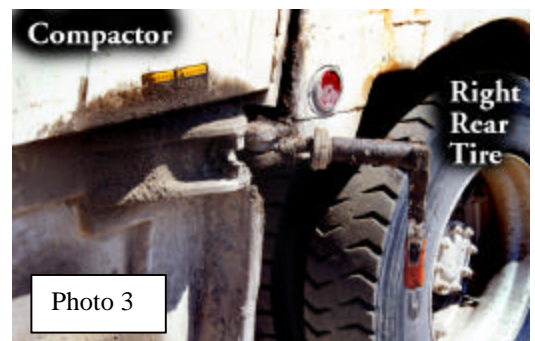
The sanitation truck owner provided verbal instruction on precautions to be followed during garbage unloading. The operator stated that both employees were aware of the verbal notification to "*stand clear*" when the hydraulic compactor was lowered. They were also aware that the operator was responsible for operating the hydraulic controls located on the driver's side of the cab, which included securing the hydraulic compactor attachment screw (see Photo 3).

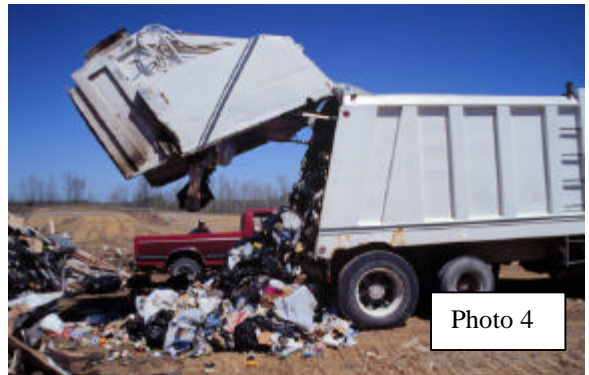
Photo 4

The garbage truck unloaded at the landfill around 2-3 times per week. The shift started at 7:30 am, and the owner and assistant collected garbage at designated locations. On this occasion, the owner drove the sanitation truck to the county landfill, with the assistant in the passenger's seat. When they came to the unloading zone at the landfill, the operator backed the truck into the designated space for unloading. The operator and assistant then left the cab and went to the back of the truck where each man unsecured the attachment for the tailgate/compactor. Since the hydraulic controls are outside the cab on the driver's side, the operator is the only employee that operates the controls. The operator raised the compactor to the upright position, (see Photo 4) emptying its contents onto the ground.

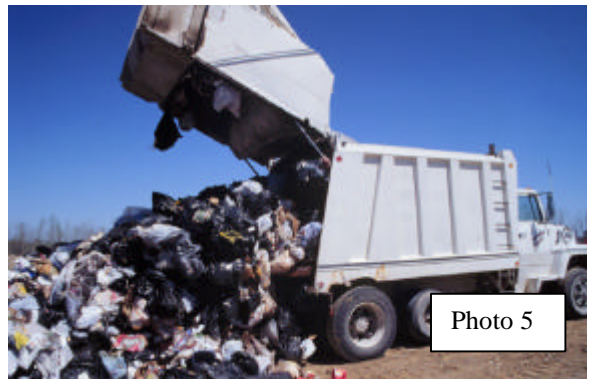
Photo 5

There is an internal plate, which remains in a vertical position at the front of the truck. This plate then moves to the rear pushing compacted garbage out of the truck (see Photo 5). The bottom of this blade was slightly damaged so there was a small amount of debris that remained on the truck floor.

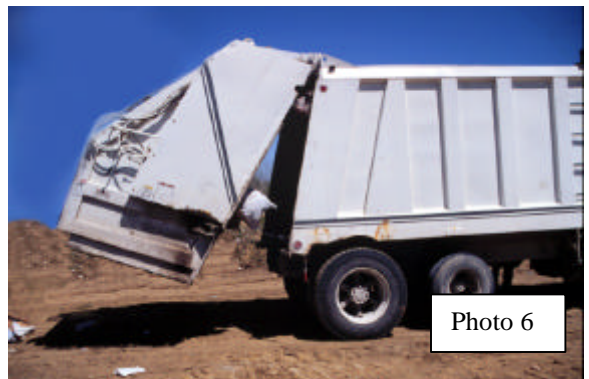
Photo 6

The operator then moved the truck forward several feet, and lowered the hydraulic compactor to the 3/4 position (see Photo 6). He returned to the rear of the truck on the driver's side. There is an attachment link on both sides of the truck that must be cleaned to ensure that the compactor will close and latch properly. The operator cleaned the link on the driver's side and the assistant cleaned the link on the passenger's side. With the compactor in the 3/4 position there is a clear line of sight between the two employees, and the operator looked at the assistant and shouted to the assistant to "stand clear". The assistant signaled a response.
