FROM: Iowa FACE Program

Case No. 3IA72

Report Date: 17 June 2005

SUBJECT: Overturn of a Tractor with ROPS Folded Down Kills Operator

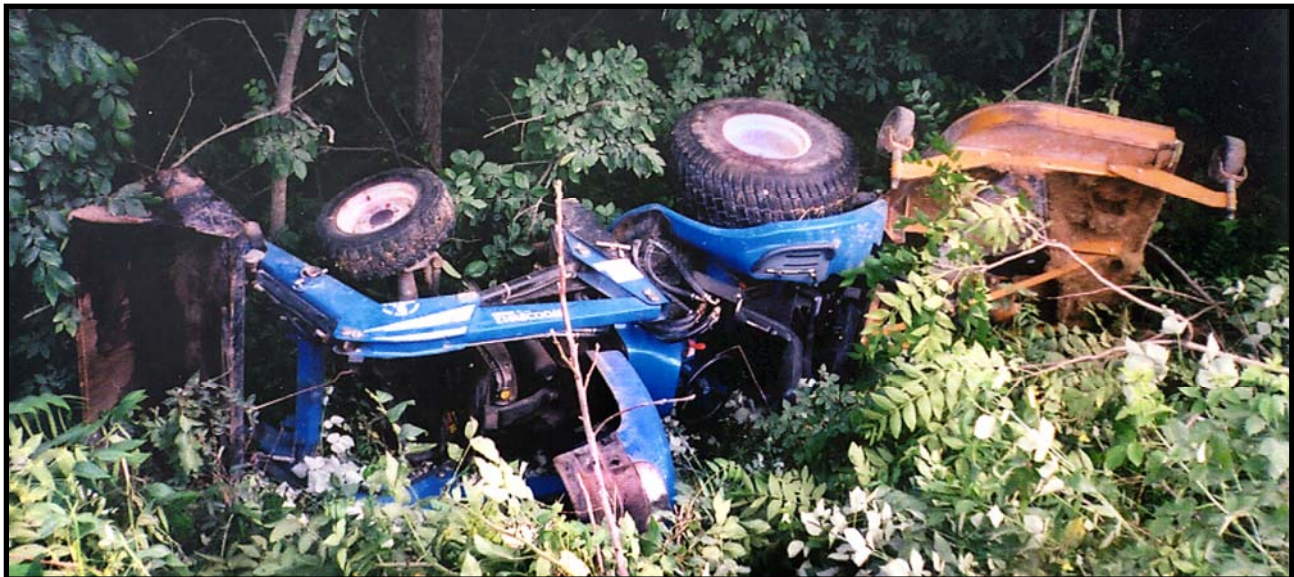
Photo 1 – Side view of the tractor in a roadside ditch after the overturn.

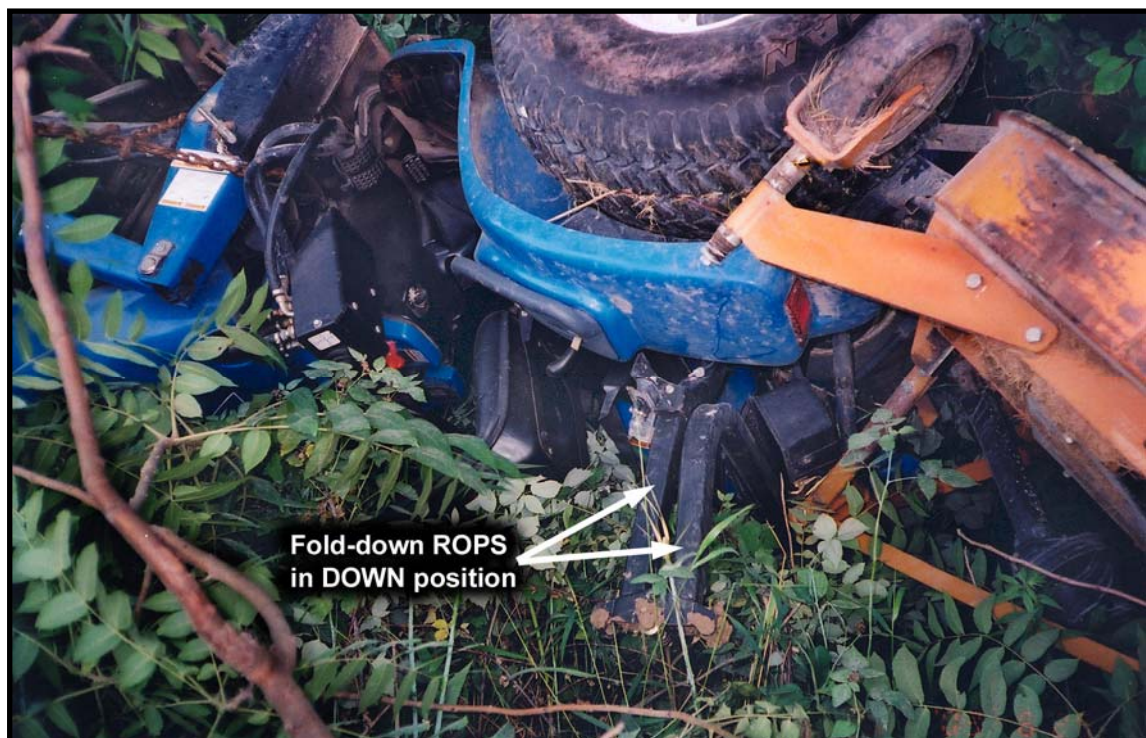
Photo 2 – Upside down tractor in the ditch, with foldable ROPS in the down position.
Notice the mud around the hinge area from digging into the ground during overturn.

Discussion: One of the barriers to increased installation of ROPS has been the complaint that ROPS interfere with using tractors in low clearance situations, such as low buildings and orchards. The manufacturers of tractors and ROPS have responded to this concern by manufacturing fold-down-type ROPS, which are very common in newer open-station tractors. A concern remains that the fold-down ROPS can easily be left in the down position, and seldom, if ever, returned to the upright position. This fatality, to our knowledge, is the first case in Iowa where a folded-down ROPS was involved in a fatal tractor overturn. Owners and operators must be reminded that leaving the fold-down ROPS in the down position renders it ineffective. It must be returned to the upright position after any low clearance work.

Recommendation #1 *Operators should return retractable ROPS (foldable or telescoping) to their upright and locked position immediately upon exiting a low clearance environment where the ROPS must be down.*

There was no reason to have the ROPS in the folded-down position while driving on this road. Employers should ensure that ROPS are kept in the upright position at all times, except when necessary to have them down. It is unclear whether this ROPS was kept down routinely. Employees should be trained not to use tractors outside low clearance environments unless they have ROPS in the upright position and are wearing the seatbelt.

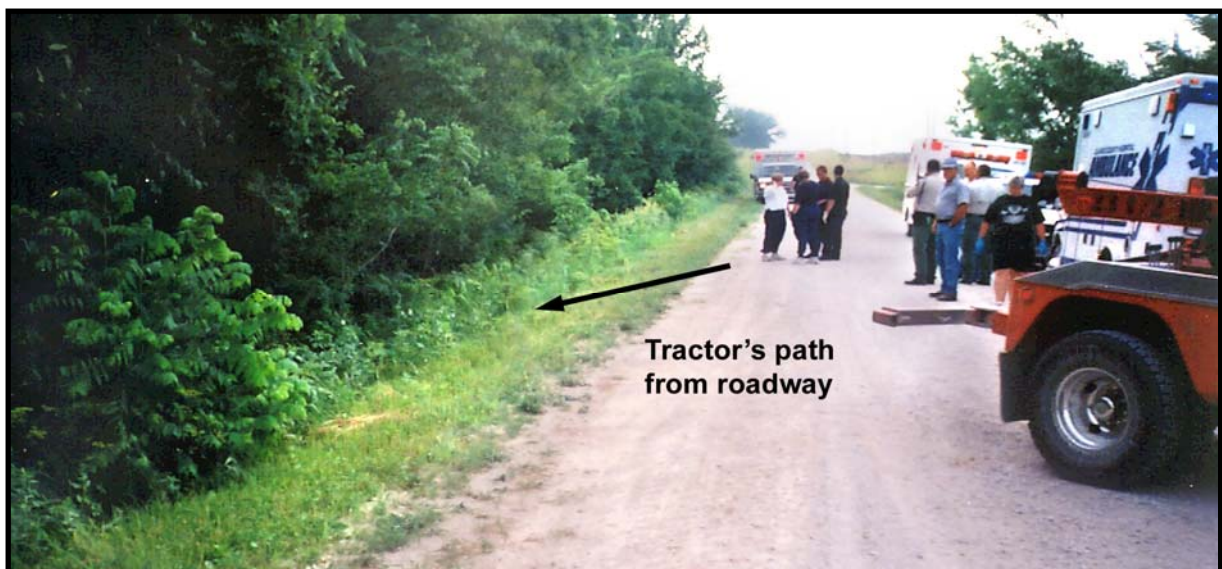
Photo 3 - Incident scene facing east, showing road conditions and path the tractor traveled into the ditch.

At the time of the incident, the victim was in transit from the nursery to the sow confinement facility. He was driving alone, heading west on the gravel road, using a compact utility tractor which he was familiar with. There was no indication of any other traffic on the gravel road at that time. The incident occurred about 6:40 AM., well after sunrise. The victim apparently lost control of the tractor and it veered into the right-hand ditch (Photo 3). He suffered fatal crushing injuries in the overturn. One of the coworkers arrived on site about 7:00 AM and found the victim dead, pinned under the tractor's left rear wheel. He went to tell the supervisor, who called 911. The Iowa State Patrol and ambulance arrived quickly, but the victim was dead at the scene. The rollover incident was not witnessed.
