**Case No. 04IA60**

**SUBJECT: 53-Year-Old Cattle Farmer Entangled in Exposed Rotating Conveyor Shaft**

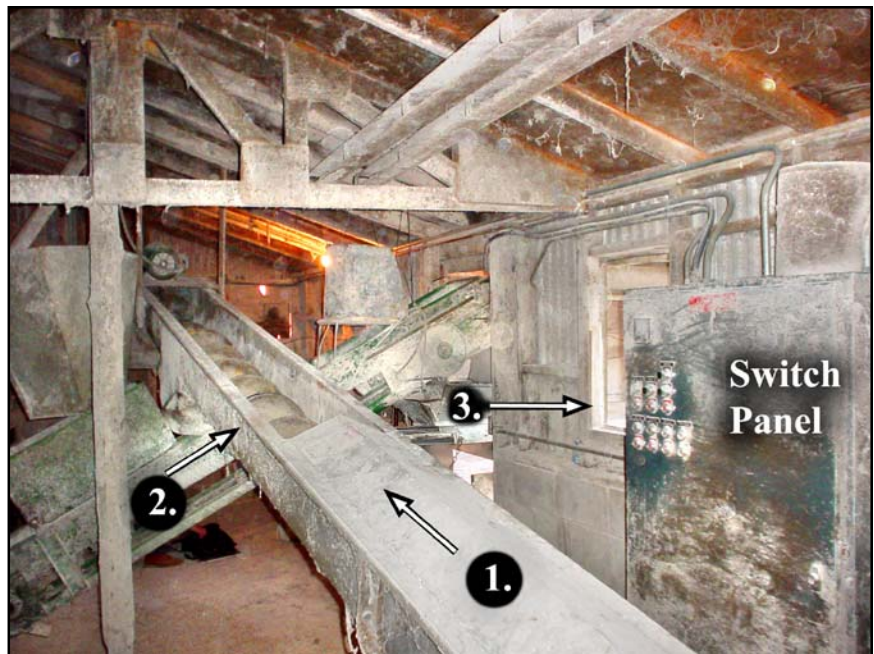
Photo 3 – View of the shed from the west end showing auger (1) bringing ground corn from the oxygen-limiting silo, conveyor (2) bringing silage from the concrete silo, and the horizontal conveyor belt (3) taking mixed feed to the feedlot on the right. The normal working position was to the left of the switch panel.

**Recommendation #2 - Control switches and stationary machinery should be placed so that there is no need to work close to hazardous machine parts.**

**Discussion:** The overall layout of the conveyors and augers in this feed shed created unsafe working conditions. The electrical controls for this feeding system were consolidated, but to access them the farmer often had to crawl under the main feed bunk conveyor. For mixing other feeds into the conveyor, he would have to go back to the other side again to manually move corn and/or other supplements to the conveyor. It is difficult to place conveyors, augers, and controls in a feeding system so that there is no need to work close to moving machine parts. However, with careful planning most hazardous work circumstances can be avoided.

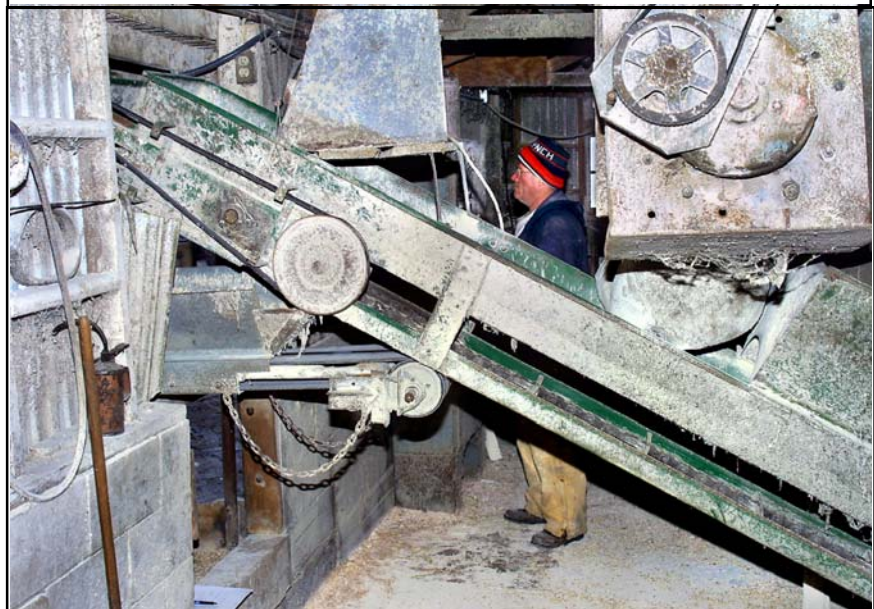
Photo 4 – View of conveyors from the doorway end of the shed, showing the farmer's normal work position, with the exposed ends of the horizontal conveyor at waist level.

The farmer's normal feeding chores would take about 30 minutes early in the morning. As ground corn was moved from the silo by the auger, he would add cracked corn by bucket from a pile near the doorway of the shed. Photo 4 shows his normal work position at this time to the left of the switch panel. This task required the farmer to crawl under the exposed end of the horizontal conveyor belt a few times each day to access the switches, open and close the oxygen-limiting silo, and add corn to the feed. The farmer had become accustomed to doing this every day.
