Case No. 31A55

Report Date: 8-8-2004

SUBJECT: Construction Worker Electrocuted When Boom Forklift Contacted Power Lines

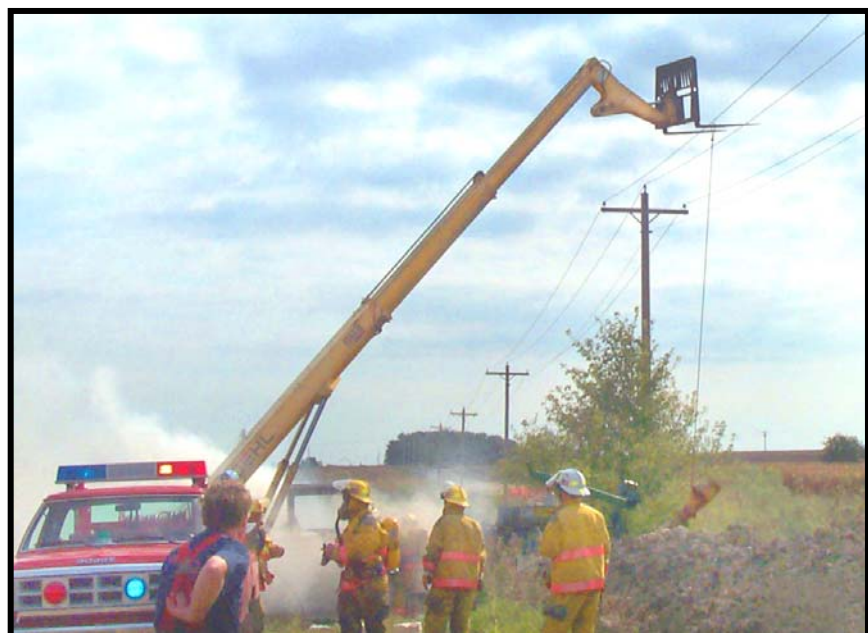
Photo 1 – View of firefighters at the scene, showing the forklift near the powerlines and the pump suspended by a wire rope cable.

According to Photo 1, the boom on this forklift was raised approximately 45 degrees, while the maximum angle was 74 degrees. The photo also shows the boom in a fully extended position.

From Photos 1 and 2, the pump is seen to the south of the grassy work area, with the hydraulic lines trailing in a straight line behind, suggesting it was being moved into position at the time of the electrocution.

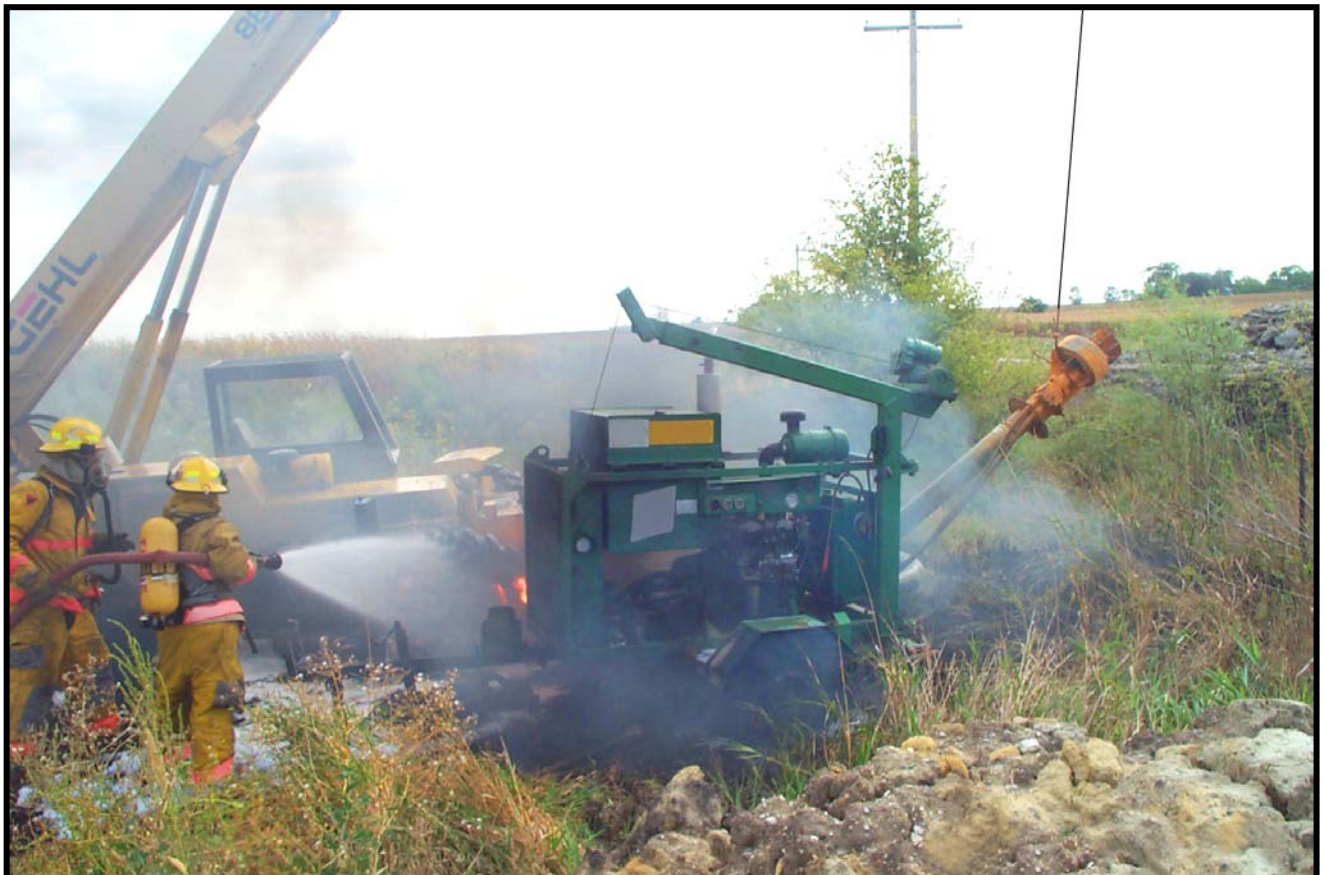
Photo 2 – Second view of firefighters at the scene, showing the portable hydraulic power unit and the suspended

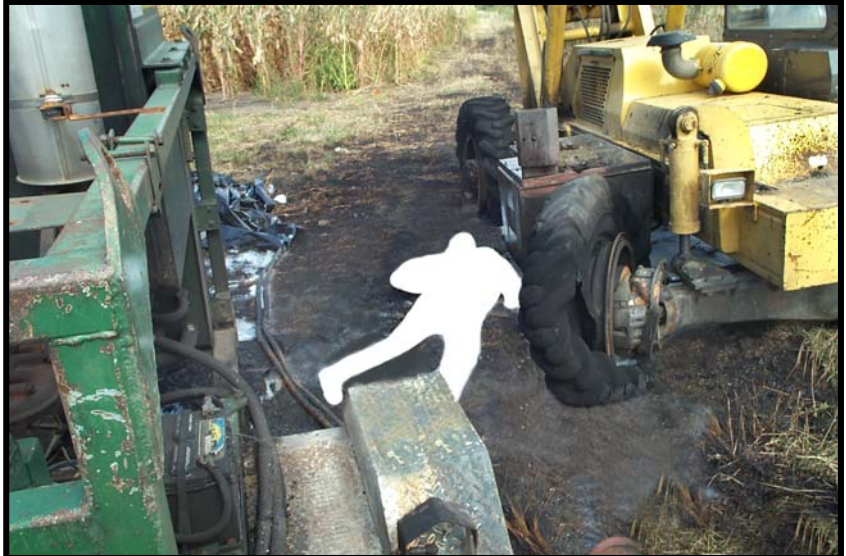
Photo 3 – View between the forklift and the hydraulic power unit, facing north, showing position of the victim after he fell to the ground.

At this time, the forklift operator was communicating with the victim, most likely through the open front window of the cab. He asked if he had sufficient clearance from the powerlines and the victim gave him the thumbs-up sign. Then suddenly the forklift came in contact with the northernmost powerline, and the victim, who was standing on the ground, was instantly electrocuted. The victim was hanging onto the hydraulic lines with his right arm, and standing next to the hydraulic power unit, facing the operator when he was electrocuted (see Photo 3).

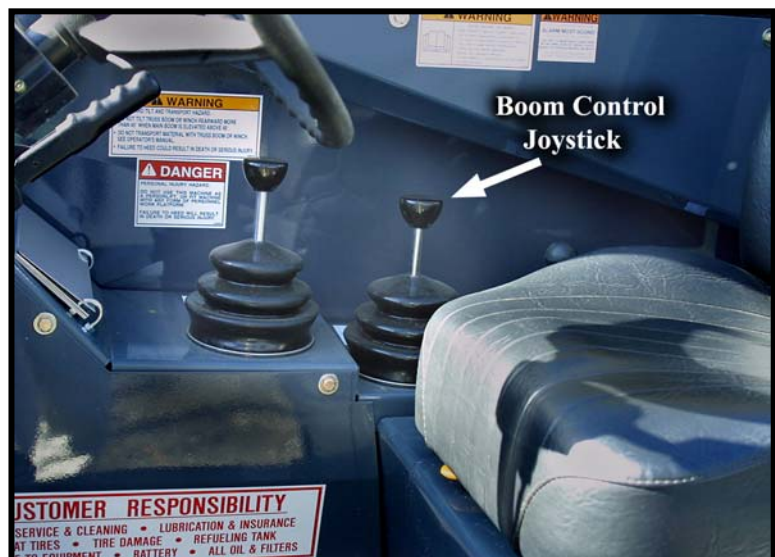
Photo 4 – View of cab area of a new identical forklift, showing position of the joystick which controls the boom.

Photo 4 shows the right side of the operator's area, which had three hydraulic controls: the front lever for the fork attachments, the middle 4-way lever for the boom itself, and the 2-way frame-leveling control to the rear. The middle control moved forward and backward to lower and raise the boom, and left and right to retract and extend the boom respectively.

If the operator was leaning far to his right, it might be possible to inadvertently push the middle lever to the right and extend the boom, but leaning to the right seems very unlikely due to the fixed window on the right side of the cab. This model of forklift had the front and left sides of the operator's area completely open, while the right side window and rear window were permanently sealed. The top of the operator's area was also open, with heavy cross members to protect from falling materials. The right window is always present and fixed as part of the safety requirements for this machine, protecting the operator from dangerous movements of the hydraulic components, which pass just a few inches from the window. Photographs confirm the presence of the right side window on this machine (see Photo 3), therefore, verbal communication between the workers had to be through other areas, most likely the front window area.

The forklift was a Gehl model 883, about 8-10 years old. The machine had an 8000 lb. (3600 kg) capacity with a 40 ft. (12 m) maximum lift height. The boom was raised, lowered, extended, and contracted with a single control lever to the right of the operator's seat (see Photo 4). The forklift was situated in a grassy area on the north side of overhead powerlines. The wires carried 12, 460 volts of three-phase power, and were 26 ft. 7 inches (8 m) from the ground at this location. The area to be drained was on the south side of these powerlines. After preparing the pump, the men were going to drive the forklift forward with the suspended pump and place it in the wet area south of the wires. A portable hydraulic power unit was already moved into position, sufficiently close to the wet area so that the hydraulic lines could be connected.

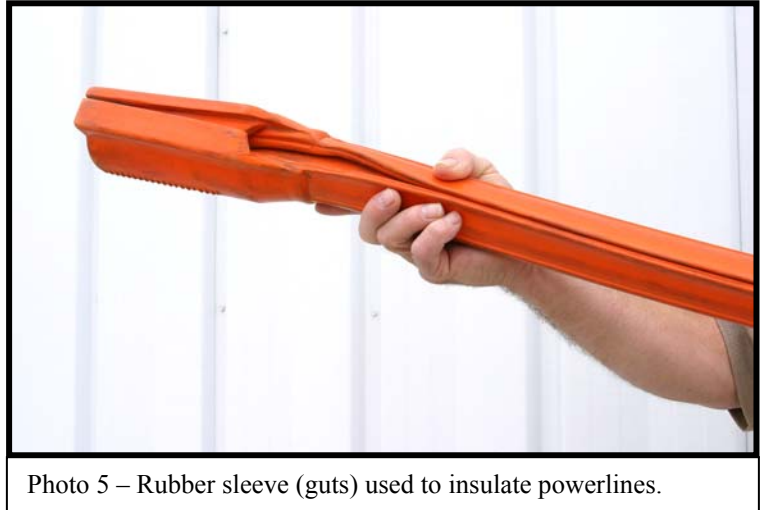
Photo 5 – Rubber sleeve (guts) used to insulate powerlines.

Discussion: Utility companies will apply insulators or cover-ups to powerlines if construction companies will ask. These are five-foot long orange rubber sleeves (commonly called guts) that are joined end-to-end over the wires, designed to prevent electrical contact with machinery or men (see Photo 5). Locally, this is a free service, and utilities are happy to do this to avoid possible outage or serious injury in case of contact. When contractors encounter transformers and other complex overhead electrical arrays, utilities can also use rubber blankets or other special means to insulate their equipment. It is the responsibility of every contractor to determine ownership of powerlines servicing and passing through areas where they are working. The use of insulating barriers is one listed requirement by OSHA, if equipment is expected to come within 10 feet of energized powerlines [CFR 1926.550(a)(15)(i)]
