**FROM: Iowa FACE Program**

**Case No. 3IA60**

**Report Date: March 17, 2004**

**SUBJECT: Farmer Crushed in Machine Shed Doorway While Using Skid-Steer Loader**

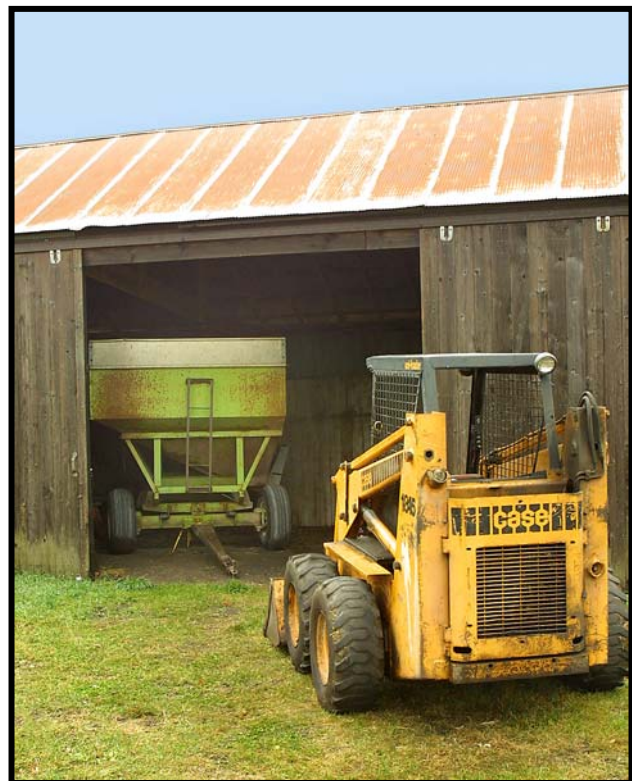
Photo 1 – View of the skid-steer loader, grain wagon, and machine shed (loader backed up six feet).

It's not clear how the farmer initially activated the hand controls. Perhaps he attempted to move the loader while standing on the ground, however, his wife had never seen him do this. He could have lost his balance when entering the loader, and accidentally hit the raise lever. In any case, the control or the valve raising the lift arms became stuck and continued to raise the lift arms crushing the farmer in the bucket up against the doorway header. His feet were inside the shed, and his arms pointed toward the rear of the loader. The loader stalled in this position, for the machine was not running when the man was found by his wife. She tried unsuccessfully to start the loader, then went to the house and called for rescue. Firemen were able to start the machine and lower the bucket, but the man was dead at the scene from asphyxiation. The loader was then backed away from the building to the position seen in Photos 1 and 3.

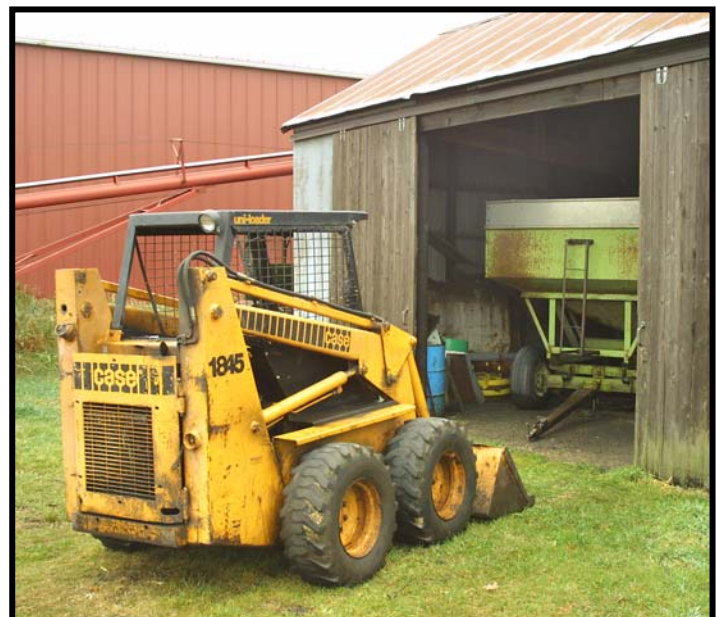
At the time of the incident, the skid-steer loader was approximately in the same position as shown in Photo 2, only 6 feet (1.8 m) more forward, with the bucket in front of the wagon in the doorway. Normally, the farmer would insert the front edge of the bucket inside the tongue hitch, raise the tongue a bit, then push and steer the wagon into position. The wagon tongue had the

Photo 2 – Another view of the skid-steer loader, grain wagon, and machine shed.

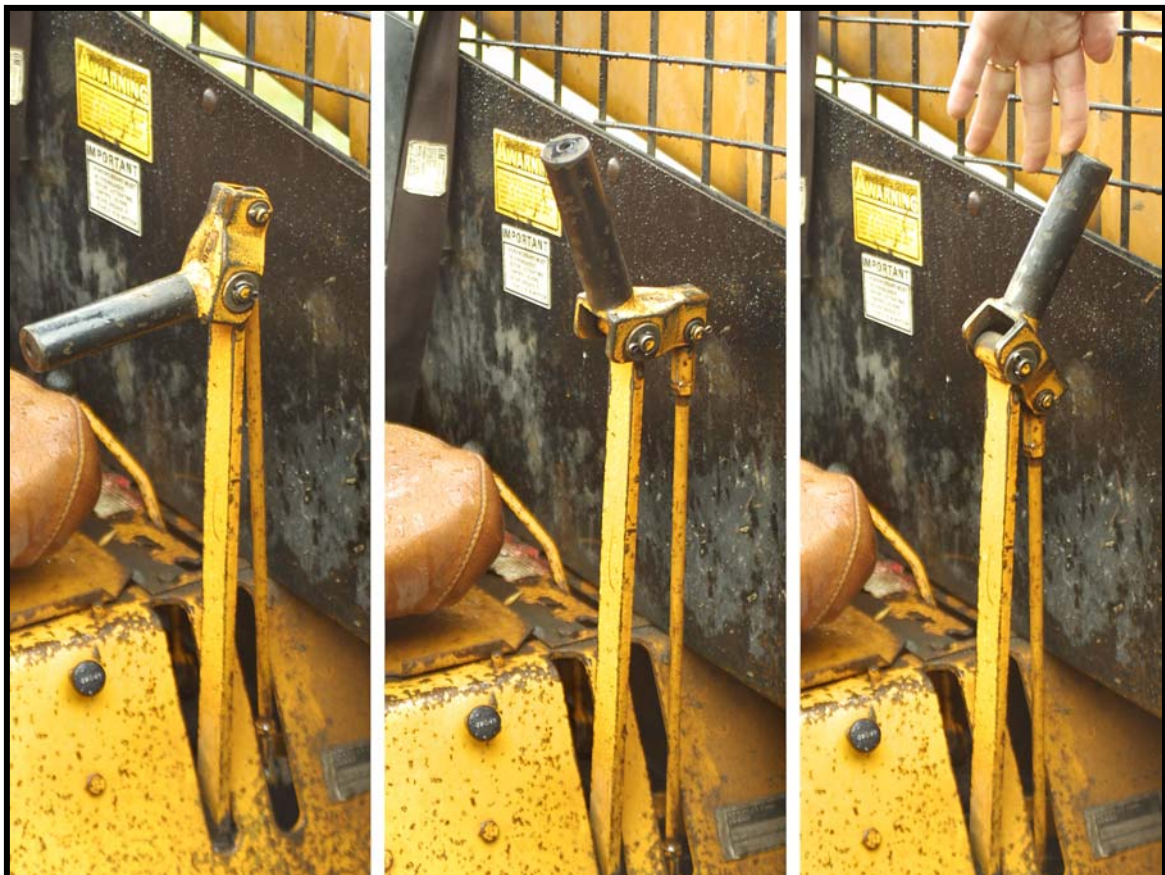
All loader movements were controlled by two hand controls, which, during our investigation, showed considerable wear (see Photo 3). If pushed to the extreme position, the lift arm control would stick in the down (but not up) position, with the engine not running. The farmer was found crushed up against the header by his wife, who tried unsuccessfully to start the loader, then called 911. When rescuers arrived, they were able to start the machine and lower the bucket and the victim to the ground.

Photo 3 – Three images of the left hand control. The control handle stuck in the DOWN position (left), the handle in neutral (center), and the handle held in the UP position (right).

Photo 3 shows the hand control for the left side wheels and the lift arm height. The left image shows the control stuck in the down position, the middle image shows the control in neutral position, and the right side image shows the control in the up position. The hand controls are designed to return back to the neutral position by centering springs inside the machine. During our investigation we noticed that the controls had significant wear. Due to this wear and/or the weak centering springs, the lift arm lever easily stuck in the down position, as shown on the left image. The machine was not operable at the time of our investigation, and it wasn't clear if the hand controls or the hydraulic valves were also sticking when activated, with the engine running. One of these malfunctions was necessary for this incident to occur, for the bucket continued rising, even when the victim was not in the operator's seat.

The skid-steer loader was a Case Model 1845, manufactured in 1977, and bought used in 1989. It did not have any electrical or mechanical interlocks built-in, but did include a seatbelt. This skid-steer loader was involved in a machine fire 2-3 years ago, the fire starting under the right rear portion of the seat, sparked from a worn battery wire to the ignition. Apparently due to machine vibration, this wire had worked loose, worn through and shorted out causing the fire, which quickly spread underneath the machine due to an accumulation of dry corn stalk debris. The machine was repaired following this fire. It is possible that the fire damaged the linkages, or weakened the left centering spring for the hand control linkage, making it unable to return the lever back to a neutral position.

**Discussion:** The older skid-steer loader had wear from previous use. The control linkages were worn, and in need of adjustment and repair. The left side control for the lift arms had a weak centering spring, and the control did not return to the neutral position as designed. After it was activated, the loader kept rising, which could have been caused by a sticky linkage or hydraulic

valve. The centering spring is a very important safety feature in the controls, and should be maintained in operable condition.
