THE UNIVERSITY OF IOWA
Iowa City, Iowa 52242

FROM: Iowa FACE Program Case No. 01IA03801 Report Date: January, 2002

SUBJECT: Operator of Skid-Steer Loader Killed When Thrown Out of Seat.

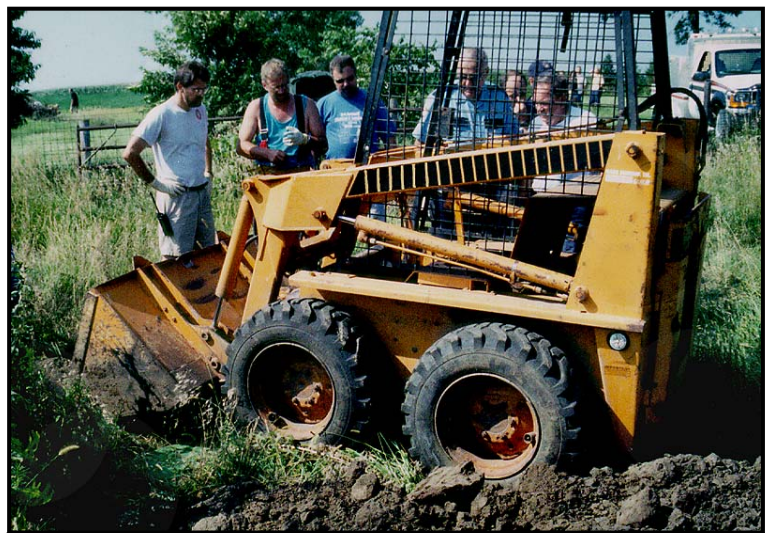
Photo 1 -- Side view of skid-steer loader after the incident.

suddenly fell off, and the machine bucked forward while going over the weights on the ground. The man and the seat of the skid-steer loader were thrown forward out of the loader, and the raised bucket came down and crushed the man against the front frame of the machine. The man was found dead about four hours later. The seat, which was found under the victim, was not securely attached, but only held in place by vertical metal pins. The seat belt had been removed from the machine.

- *Owners/operators of skid-steer loaders should not use temporary counter weights.*
- *Owners/operators of skid-steer loaders should not overload the machine by using over-sized buckets.*
- *Owners/operators of skid-steer loaders should maintain the seat and seatbelt in good condition, and use operator restraint systems while operating the machine.*

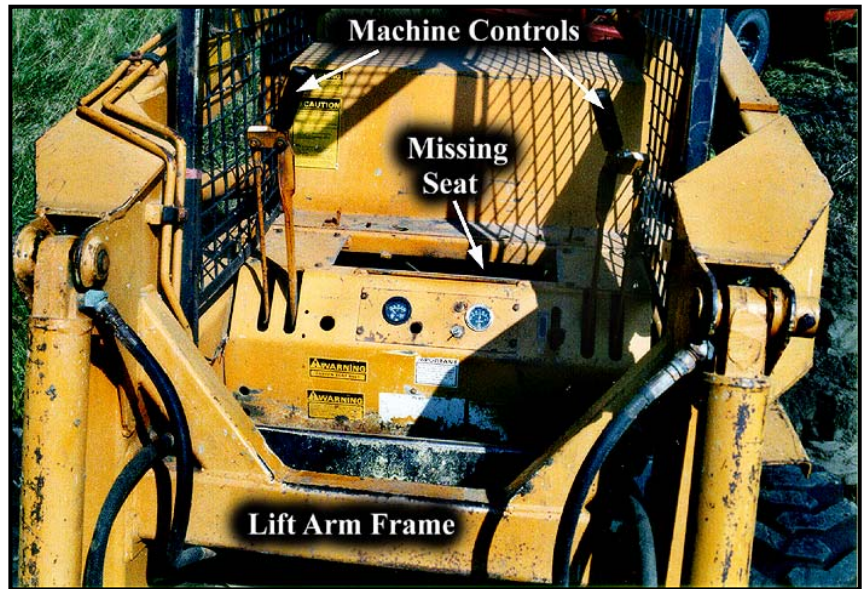
Photo 2 -- View of loader showing missing seat and seatbelt.

It is possible that the man may have pushed the control levers as he was thrown forward out of the loader, which would have caused the bucket to fall rapidly or move the machine forward (see Photo 2). The left handle controls the loader lift arms, while the right handle controls the bucket tilt movement. Moving the levers forwards and backwards controls machine forward, reverse, and turning of the loader. The machine was not running when rescuers arrived, so it had stalled during the incident. It was not determined whether this was due to an operator presence control, or otherwise stalling of the machine. The victim was crushed between the front bucket and frame of the loader, not under the bucket. It is not known how high the bucket was prior to the weights falling off, but even at mid-range, there would be enough space for the victim to get thrown out and crushed.

The missing seat (see Photo 2) was found to the victim's right, underneath him. The seat is partially hinged on its front edge and pops into place with pins into holes on the seat base. The seat is normally removed to provide access to the hydraulic pump, electrical gauges, and machine wiring. The seat belt, normally attached to right angle pieces (see Photo 2), had been completely removed from this machine. This belt would normally secure the seat and the operator during operation.

Recommendation #3 *Owners/operators of skid-steer loaders should maintain the seat and seatbelt in good condition and use operator restraint systems when operating the machine.*

Discussion: The removable seat on this machine was designed to provide access to the hydraulic pump, wiring, and other machine parts under the seat. The design of the seat attachment may not be adequate to ensure that the seat stays in place in all conditions. The seatbelt had been completely removed, leaving no protection for the operator being thrown forward. There were no other operator restraint systems besides the seatbelt in this older machine. Skid-steer loaders are inherently bouncy, and it is important in all conditions to wear the seatbelt or use other appropriate restraint systems.

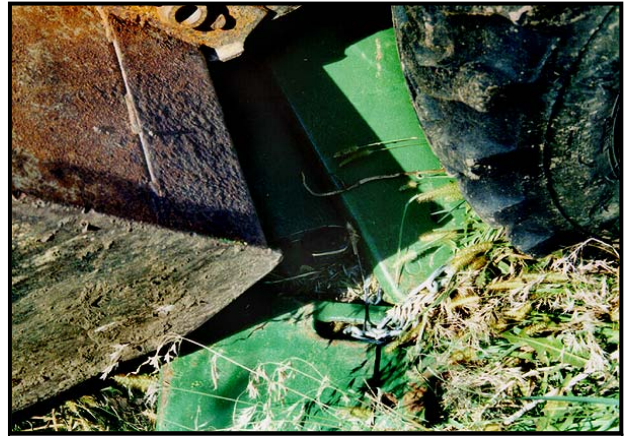
No one witnessed this incident. From the available information and photographs, it appears that the machine was backing up while the weights abruptly fell off the rear of the loader. The bucket was full of dirt and raised sufficiently to trap the operator, but it is unknown how high the bucket was at the time of the accident. When the weights fell off, and the wheels drove over them, the machine bucked forward violently, throwing the man and his seat out in front of the loader.

The weights were found underneath the victim and the bucket (see Photo 3). It is not fully clear how the bucket came down and crushed the victim between the bucket and the loader frame. It appears that there was a leak in the hydraulic control system, for rescuers stated that the lever had to be pushed constantly to keep the bucket raised. This problem may have been present before the incident, or it may have been caused by the incident. The overload of dirt in the bucket, and the violent movement of the machine could cause significant loading and failure to the hydraulic system. No further testing was done to identify mechanical failure in this hydraulic system.

Photo 3 -- Tractor weights seen under the bucket.

Recommendation #1 *Owners/operators of skid-steer loaders should not use temporary counter weights.*

Discussion: Tractor counter weights were used temporarily in this machine to improve stability and traction. The weights were attached to the back with a chain, and while loading and moving dirt, the weights fell off causing the incident. As the weights fell off, the heavy load in the raised bucket made the machine more prone to tip forward. The machine was apparently backing up and it ran over the weights on the ground at the same time, which caused it to buck violently and throw the operator out of the machine. The sequence of events is not fully clear, but it is likely the incident occurred instantly after the counter weights fell off. Skid-steer loaders are often used in conditions where bouncing or bumping into objects could cause counter weights to fall off, unless they are designed properly for the machine. This machine has available factory-supplied counter weights, which are bolted to the bottom of the machine. Only such factory-supplied counter weights should be used in skid-steer loaders.

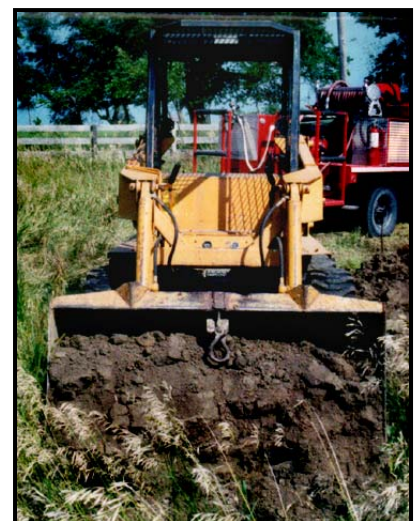
The front bucket on this loader was a utility-size bucket, designed to carry grain, silage, snow, etc. An optional smaller dirt / gravel bucket was available from the manufacturer. This smaller bucket does not require counterweights, and is recommended for construction use. The manufacturer does provide an optional counterweight -- a large metal plate, which is bolted to the bottom of the machine. Photo 4 shows the utility bucket full of dirt at the site of the incident. Using this utility bucket for moving dirt was likely the reason for needing the extra weights at the back of the machine. A mechanic we consulted had concerns about the weight when handling dirt with this bucket.

Photo 4 – Front view of loader bucket full of dirt.

Recommendation #2 *Owners/operators of skid-steer loaders should not overload the machine by using over-sized buckets.*

Discussion: A fairly large utility bucket was used for loading dirt in this case. This bucket is designed for general use and lighter materials such as snow, grain, etc. Handling full loads of dirt will exceed its designed capacity. It is evident that the temporary counter weights were needed to compensate for the large size of the bucket. With appropriate counter weights, the machine operation would have been safer, although it would cause excessive wear and tear on the machine. A smaller bucket was available for this machine, designed for handling heavy soil, dirt, and gravel.
