FROM: Iowa FACE Program Case No. 2IA51 Report Date: 7/23/2003

SUBJECT: Farmer Falls to His Death from Grain Bin Ladder

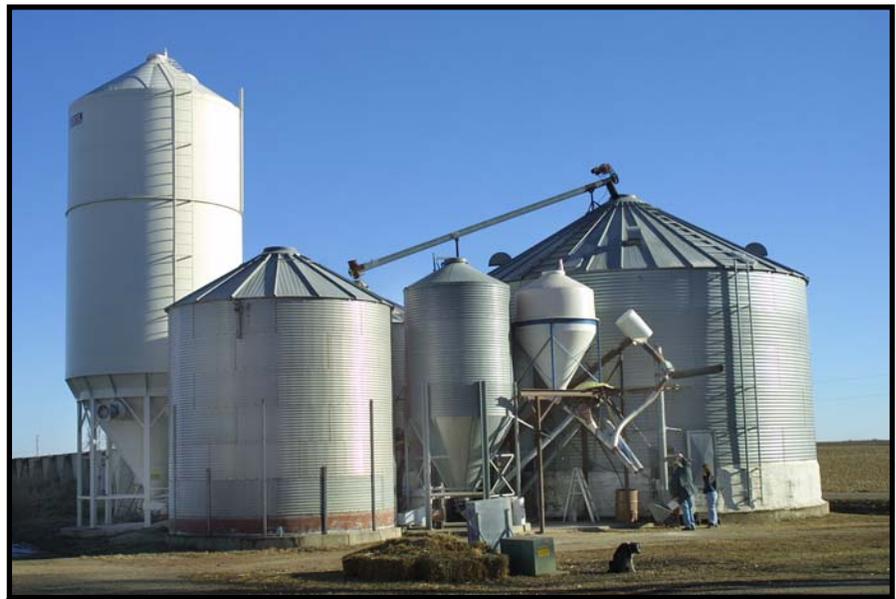
Photo 1 – Group of grain bins at the farm, facing Southeast.

The grain bin involved in this injury (to the right in Photograph 1) was built in 1986. Other bins were added to this facility in 1988-89. The facility had four corn bins and additional smaller bins for feeds and supplements. Each bin had an auger connecting to the central auger, which was used to feed the grinder mixer to mix corn, soy meal, alfalfa, minerals, and other supplements for livestock feed.

After this incident, new grain bin ladders (outside and inside the bin) were added to the west side of the bin (see Photo 1). These new ladders are similar to the old ones, but have no obstructions and no concrete pad underneath. A new access door and ladder/walkway to the central opening was also added.

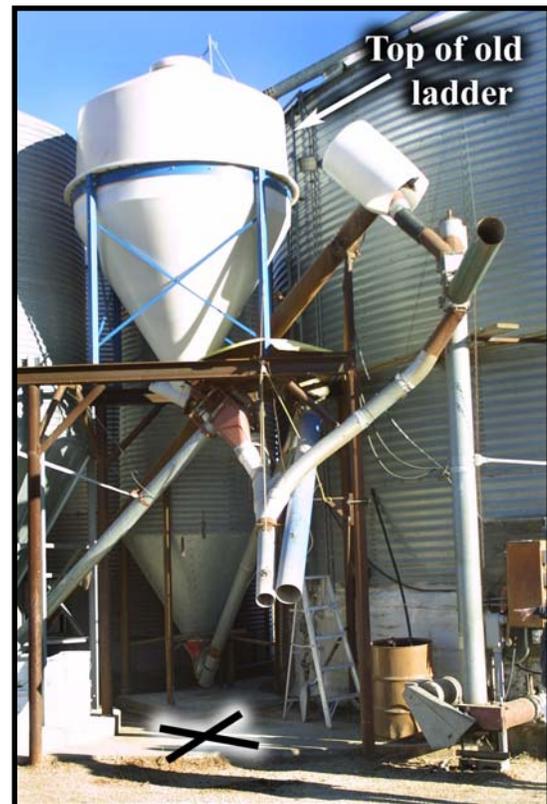
The original ladder for the large bin was located on the north side, the top barely visible in Photograph 2. The ladder was about 24 foot (7.2 m) tall. A smaller bin had been constructed very close to this ladder, so that one had to climb the ladder at a slight angle (see Photograph 3). The ladder was used frequently to reach the access door on top of the bin. There was no cage around the ladder, nor were there other means to prevent or arrest falls from the ladder.

Photo 2 – Side view of old grain bin ladder and concrete pad where the victim fell.

auger, hitting his head on the concrete pad below (location marked with an X). He was stunned, but conscious, and walked to a nearby lawn to lie down.

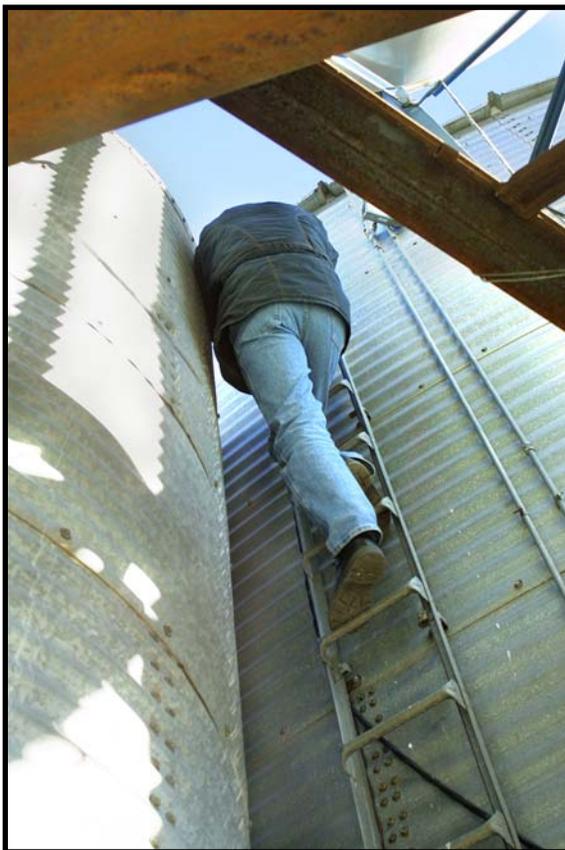
bin, leaving less than adequate clearance for the ladder, which made it somewhat difficult to climb the ladder in a normal fashion. When using this ladder, one would need to lean slightly to the right (See Photo 3). While grinding feed with his son, the farmer was climbing down the ladder after checking the grain bin. He fell approximately 10-12 feet (3-3.6 m) and hit his head on the concrete slab (See Photo 4). He was able to get up, and went to lie down on the lawn and his son called 911, against his father's wishes. The man was taken to a local hospital, then, transferred to a regional hospital by helicopter. He lost consciousness and rapidly deteriorated and died the next day from his head injuries.

Photo 3 – View from the ground looking up the old grain bin ladder.

Discussion: In this case the ladder did not have adequate clearance to climb the ladder in a normal fashion. The newer grain bin added next to the original grain bin was too close to the ladder, and forced the worker to lean to his/her right side when climbing. This may compromise the worker's ability to hold on to the ladder and have secure footing at all times. 29 CFR 1910.27 also specifies how much clearance is need around the ladder, and these specifications should be followed regardless whether the standards are enforced on farms or not.

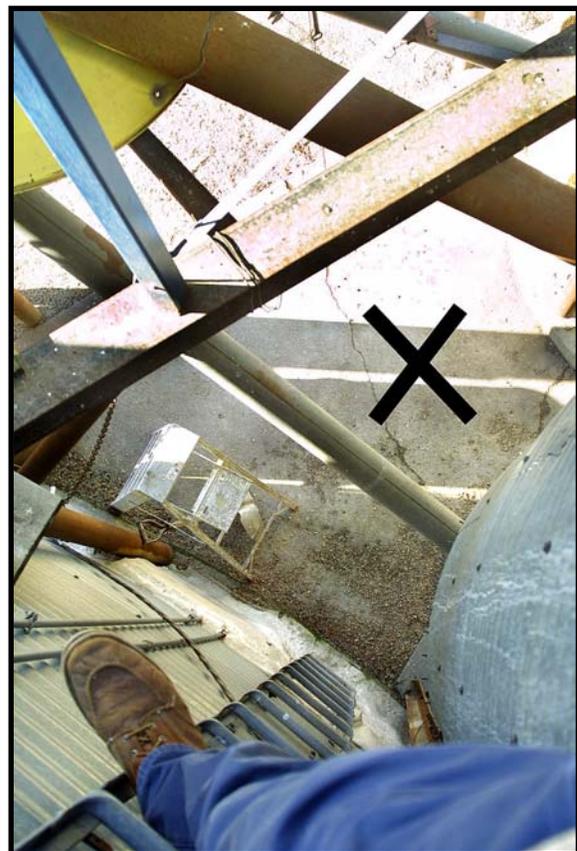
On the day of the incident, the victim was working with his 17-year-old son, mixing and grinding feed as they had done many times in the past. The large bin was about 2/3 full of corn, and contained some clumps of out-of-condition corn. Both the farmer and his son had been up in the bin that morning, apparently checking the level and condition of corn and breaking up any clumps that could clog up the auger. The son came down the ladder first, followed by his father. About half way down, the farmer apparently slipped and lost his grip, and fell backwards off the ladder. He may have hit an auger first (visible in Photograph 4) as he fell over to the other side of the

Photo 4 – View from the top of the ladder, showing area where the farmer fell.
