FROM: Iowa FACE

Case No. 2010IA017

SUBJECT: Fatal burn injury while bulldozing and burning brush

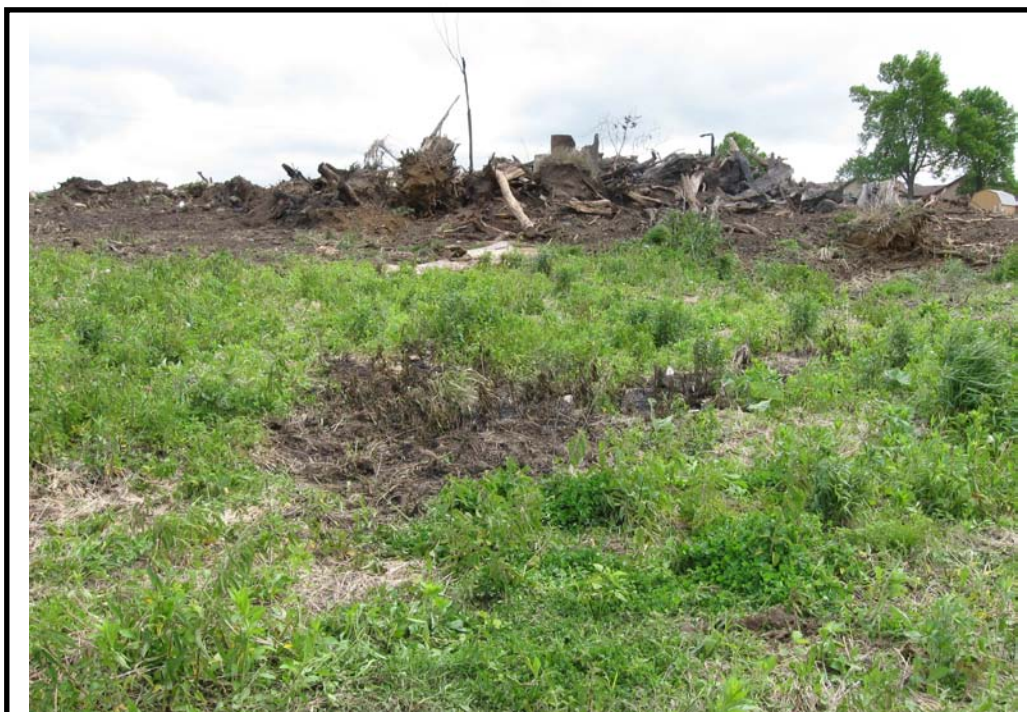
The victim was a 74-year-old self-employed construction worker with more than 20 years of experience in the field and 16 years of professional experience driving a bulldozer. The victim was helping a friend clear trees and brush from a field, and he was using a bulldozer to push trees, brush, and debris into a burn pile. The victim was driving a 1978 bulldozer that he owned and maintained. The burn pile was located 50 yards from the road and encompassed approximately 20 yards. The victim was pushing brush northwards into the pile, with wind blowing from the north/north-east. Data from the regional weather station approximately 23 miles away, winds were blowing from 10 to 14 mph with gusts up to 18.4 mph. Based on a burn area on the ground, the bulldozer caught fire approximately 20 yards from the burn pile.

Exhibit 1: Burn pile and burn area on ground where bulldozer is believed to have caught fire

Recommendation 1: *Open fires should always be attended and supervised. Machinery should not be operated near open flames.*

Discussion: Fire investigation expert John Walker described open burn piles as "treacherous" and cautioned that work should not be done near open burns. The Massachusetts State Fire Marshall recommends that an adult attend open fires at all times when they are burning. Machinery should not be operated near an open burn.

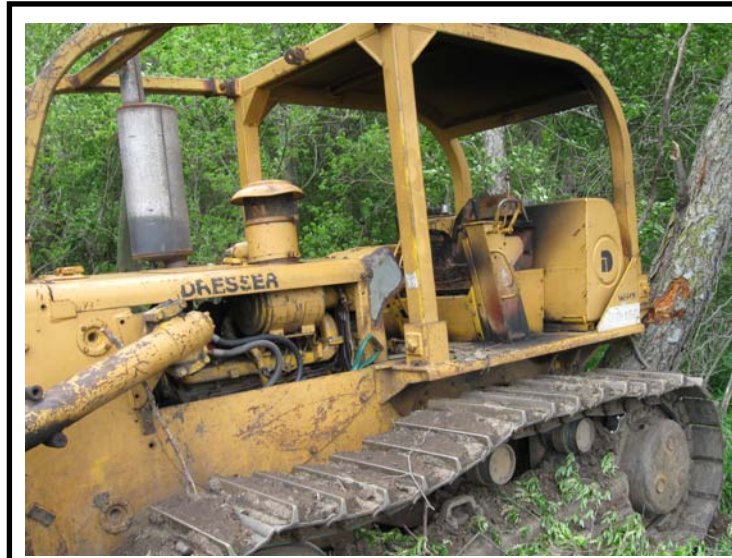
Although the victim was severely burned, he managed to put the bulldozer in reverse and exit the bulldozer. The bulldozer proceeded backwards approximately $\frac{1}{4}$ mile until it ran into some trees. It remained in that position until the property owner's checked on the site, approximately 30 minutes after the event. The bulldozer was still running, in reverse gear, and burning. The Sheriff's office investigated the next day and found that the seat and battery compartment under the seat were

Exhibit 2: Location where bulldozer came to rest

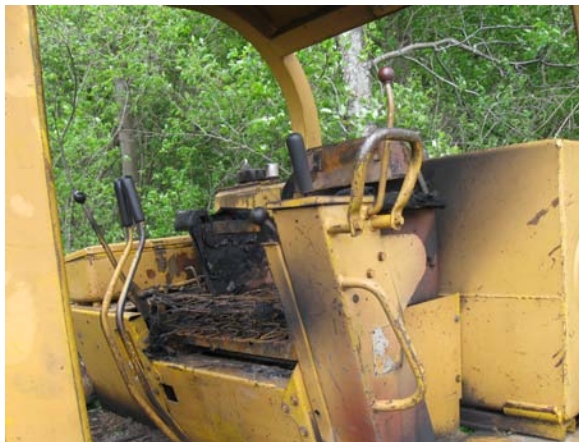
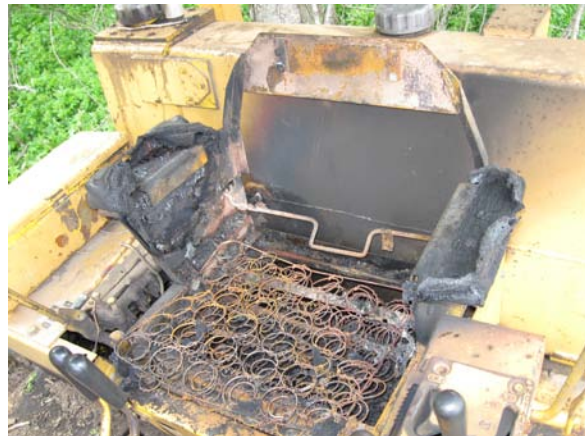
severely burned. There was a slight burn on the console, but no other burned areas on the bulldozer. When the bulldozer was turned on, there was no evidence of any hydraulic leaks running under the seat console.

Exhibits 3A and B: Burned areas of the seat and battery compartment under the seat.

The exact cause of the fire has not been determined, and it is not known if the fire started on the bulldozer or the driver. However, evidence suggests that the victim somehow got an accelerant or burn source on his clothing, which is consistent with the severity of the burns and the location primarily on the upper body. Because the burns were primarily on the upper body, it is presumed that the fire did not start in the under-battery compartment. Since the damage to the bulldozer was concentrated on the seat, with non-concurrent burns to the victim's buttocks and lower legs, it is most likely that the burns to the seat compartment occurred after the victim exited the bulldozer. Since the bulldozer continued to operate for at least 30 minutes after the fire started, the fuel source is not likely to be a fuel or fluid leak, which would have been exhausted from the fire.

- Another fuel source could have been a leak of hydraulic fuel from the bulldozer. When the bulldozer was turned on after the event, there was no indication of a leak. However, the victim's son reported on interview that the victim had recently been working on the bulldozer. Phone calls to a supply company could not confirm exactly which parts had been purchased or what had been fixed.

Recommendation 7: *Machinery should be maintained in good condition and inspected before use, with specific attention to fuel lines and possible leaks.*

Discussion: Machinery should be in good condition to ensure safe operation. Check for hydraulic leaks at fittings and by looking for drips onto cardboard or other surfaces placed below the machine prior to using it in the field. Special attention should be paid to fuel lines and other sources of flammable liquids, especially if the machinery will be near open flames.
