FROM: Iowa FACE Program Case No. 3IA21 Report Date: Aug 25, 2004

SUBJECT: Welder Falls from Boom Forklift Platform When Boom Shifts Laterally

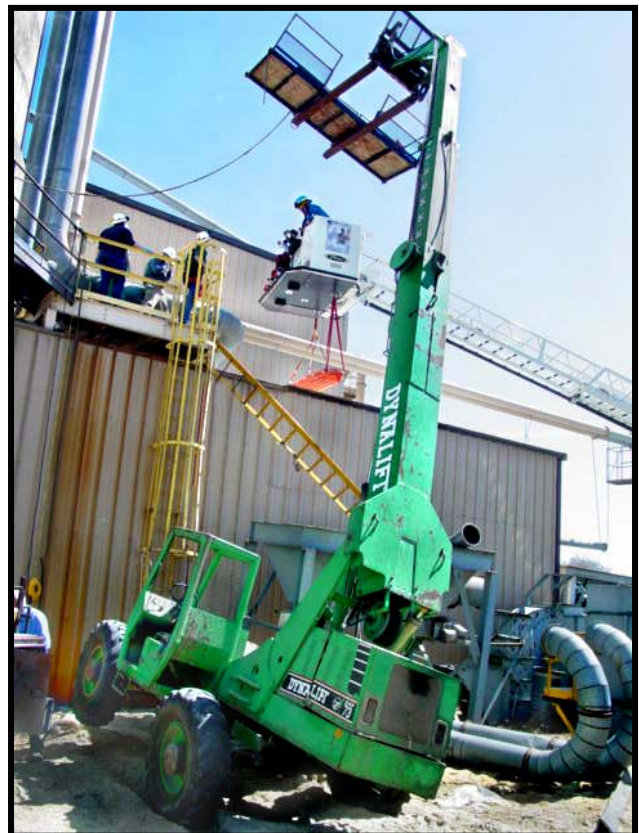
Photo 1 – Police photo of the scene showing the new catwalk, and the boom forklift, leaning to the right.

At one point, the men were adjusting the lateral position of the raised platform using the frame-tilt function (sway control) of the forklift. While moving the platform to the right, the victim yelled, "Stop", however the boom and the platform kept moving to the far right position and the victim fell off the unprotected left end of the platform, landing on the metal catwalk 20 ft. below him. The man was not wearing any sort of harness or safety line, nor was he wearing a hard hat. He sustained fatal head injuries and was dead at the scene when firefighters arrived. At that time the boom for the forklift was situated to the far right position with the left front wheel of the machine raised two feet off the ground (see Photo 1).

The left front wheel of the forklift raised two feet off the ground when the boom shifted to the far right position. It is unknown if the boom was stuck in this position, or why the boom was left in this position when firefighters arrived.

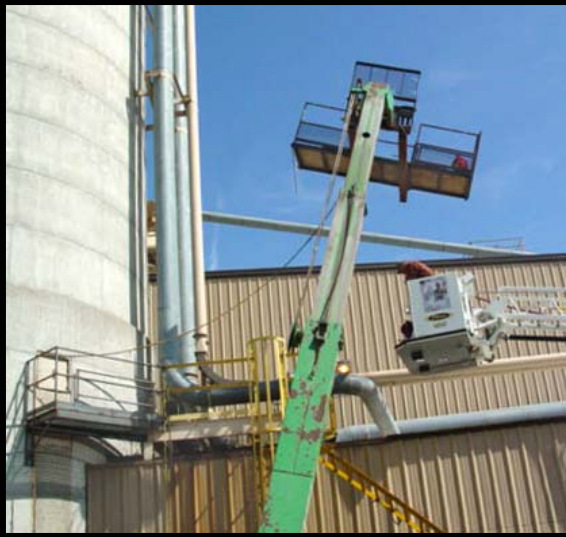
Photo 2 – Shot from the rear of the machine, showing the platform tilted far to the right.

In this case, the personnel platform was a few feet too wide. The ANSI standard for lift trucks (ANSI B56.6-2002 [8.24.1(b)])¹ states the platform floor can't exceed the overall width of a lift truck measured across the load-bearing tires *plus 10 inches on either side*. For this machine the maximum platform width would then be 96" + 20" = 116" total inches. In addition, personnel platforms must be securely anchored to the forks of the machine. In this case it appears the platform was welded to extended steel channels, which were then attached to the forks. (see Photos 2, 4).

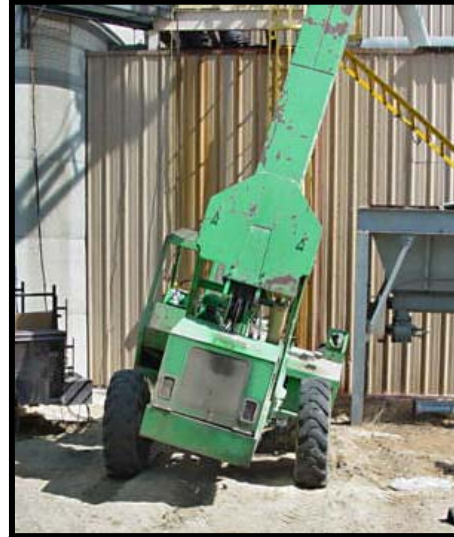
Photo 3 – View from the rear of the machine, tilted to the extreme right.

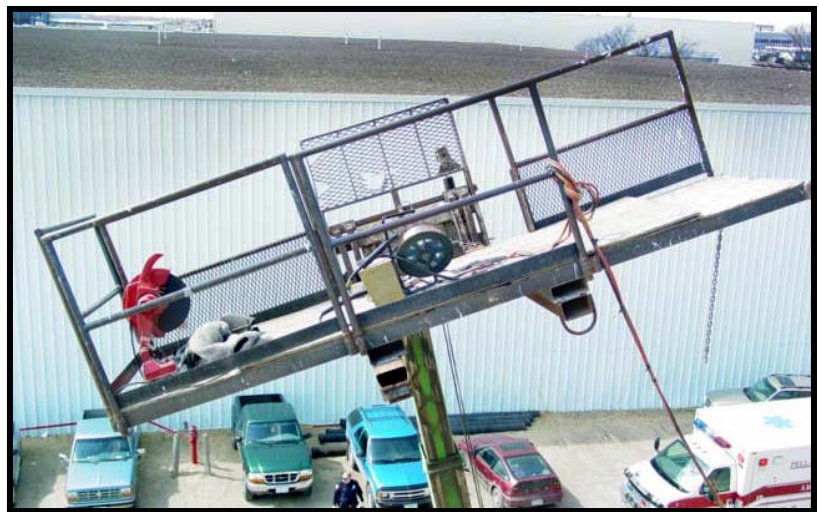
The 3-man work crew was building a new catwalk and ladder assembly on the side of a cement silo, and the victim was working on a personnel platform as a welder. Also on the platform were a wire welder, a metal chop saw, some welding hand tools, and a welding mask. The work platform was made of steel with a plywood base, and was approximately 4 x 12 ft. in size. It was constructed with seven removable metal guardrail sections, two of which were missing from the corner adjacent to the

silos where the victim was working (see Photo 4). Welded to the bottom of the platform were two 8-ft. long steel channels, which were made to receive the forks of the boom forklift truck (see Photo 5). It is not known how the extended channels were attached to the original forks of the machine. The boom forklift was routinely used in this manner for fabrication and assembly of various outdoor metal projects.

Photo 4 – View from the firefighter's ladder, showing details of the personnel platform, the tools onboard, the unprotected end, and the welded steel channels for the forks.

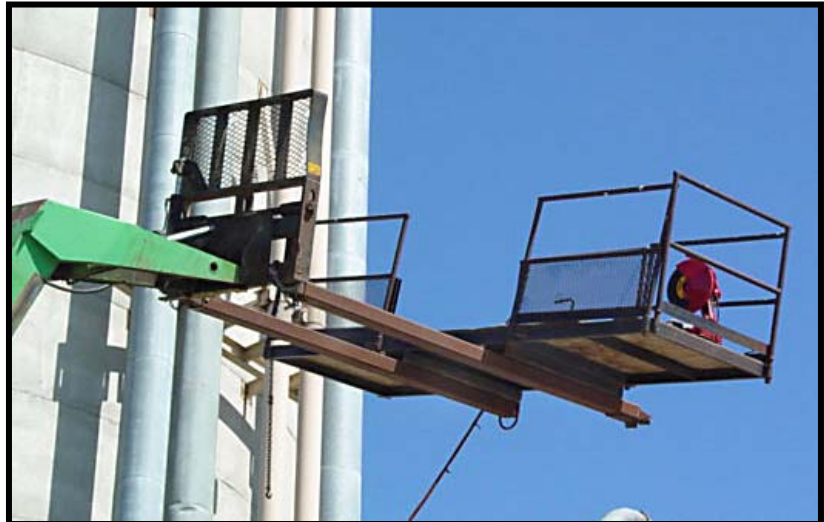
Photo 5 – Shot from underneath the platform showing the extended steel channels attached to the forks of the machine.
