FROM: Iowa FACE Case No. 2010 IA 017 Report date: 10 October 2012

SUBJECT: Fatal burn injury while bulldozing and burning brush

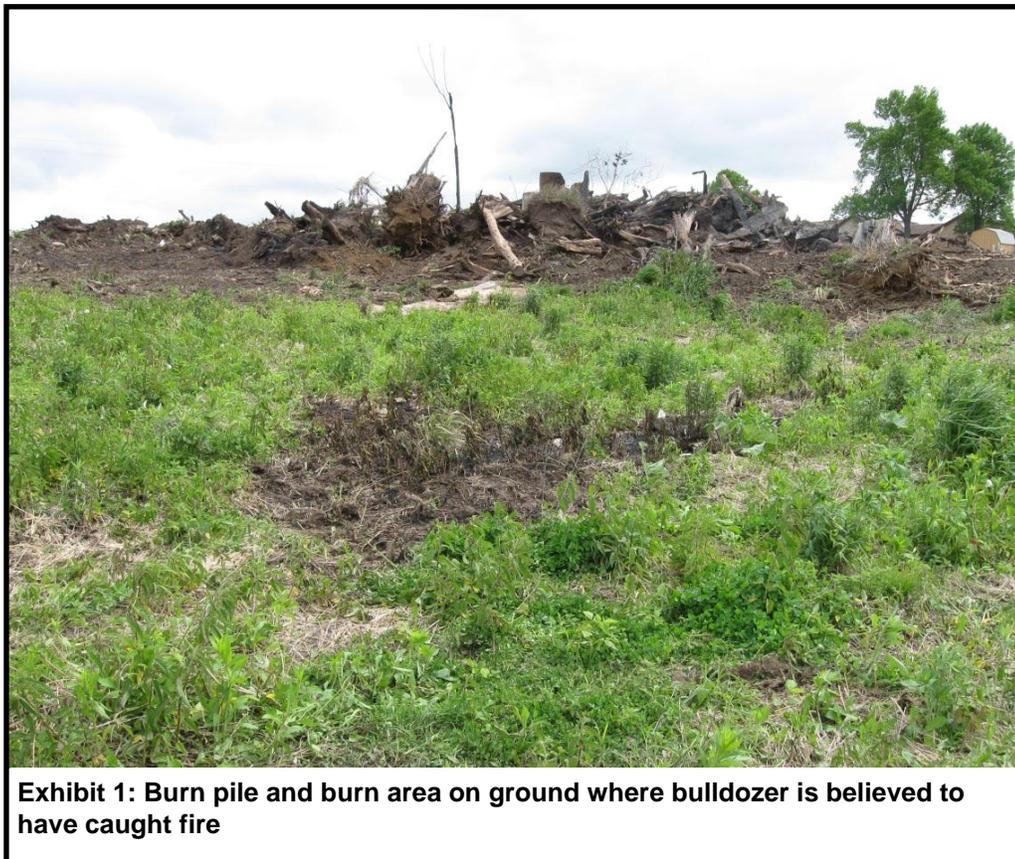
At approximately 1730, the bulldozer caught fire roughly 20 yards southwest of the burn pile (based on subsequent examination of the burn area on the ground, Exhibit 1) in what the operator described as a fireball. Although the operator was severely burned, he managed to put the bulldozer in reverse, jump from the bulldozer, and make his way to his truck parked near the field entrance.

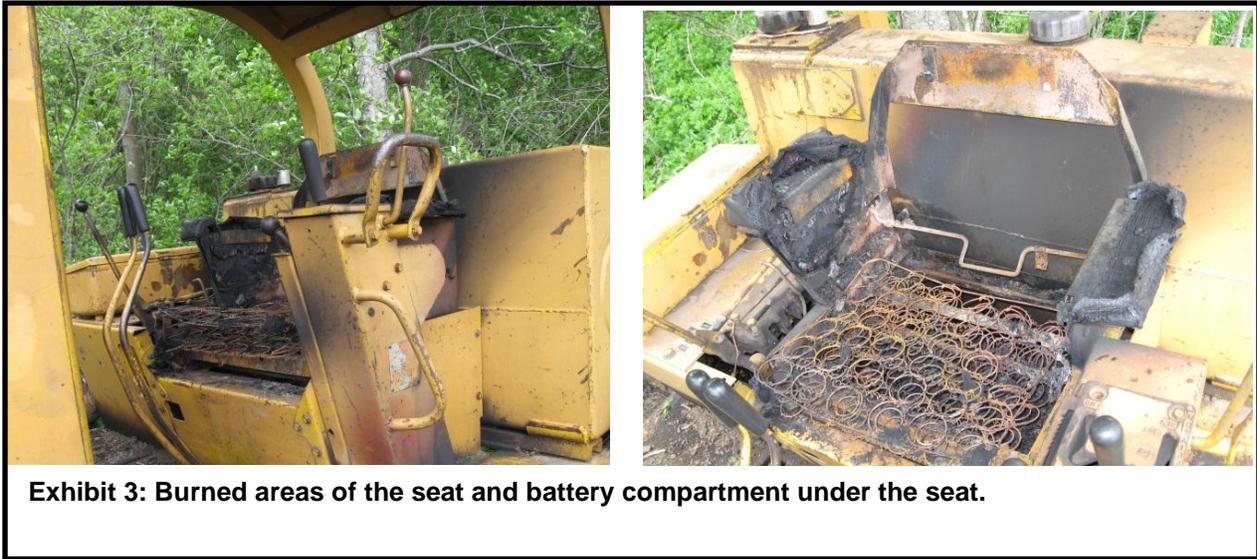
Exhibit 3: Burned areas of the seat and battery compartment under the seat.

The day after the incident, the Sheriff's office investigated and found that the seat and battery compartment under the seat were severely burned (Exhibit 3). There was a slight burn on the console, but no other burned areas on the bulldozer. When the bulldozer was turned on, there was no evidence of any hydraulic leaks running under the seat console.

The exact cause of the fire has not been determined, and it is not known if the fire started on the bulldozer or the driver. However, evidence suggests that the victim somehow may have gotten an accelerant or burn source on his clothing, which is consistent with the severity of the burns and the location primarily on the upper body. A nurse at the first hospital reported the victim's clothing smelled like diesel or gasoline. Because the burns were primarily on the upper body, it is presumed that the fire did not start in the under-battery compartment. Since the damage to the bulldozer was concentrated on the seat, with non-concurrent burns to the victim's buttocks and lower legs, it is most likely that the burns to the seat compartment occurred after the victim exited the bulldozer. Since the bulldozer continued to operate for at least 30 minutes after the fire started, the fuel source is not likely to be a fuel or fluid leak, which would have been exhausted from the fire.

Machinery should be in good condition to ensure safe operation. Check for hydraulic leaks at fittings and by looking for drips onto cardboard or other surfaces placed below the machine prior to using it in the field. Special attention should be paid to fuel lines and other sources of flammable liquids, especially if the machinery will be near open flames.
